AN EQUATORIAL QUICK CLAY LANDSLIDE, SUMATRA, INDONESIA

P.J.N. Pells

Principal, Pells Sullivan Meynink Pty. Ltd., Australia

Summary A 1993 failure of a length of bank of the Siak River in Sumatra is interpreted as representing shearing of a highly sensitive marine clay. The characteristics of the slide and the properties of the clay are in the category of the 'quick' clay slides of Scandinavia and Canada. This appears to be the first record of a quick clay slip in an Equatorial area.

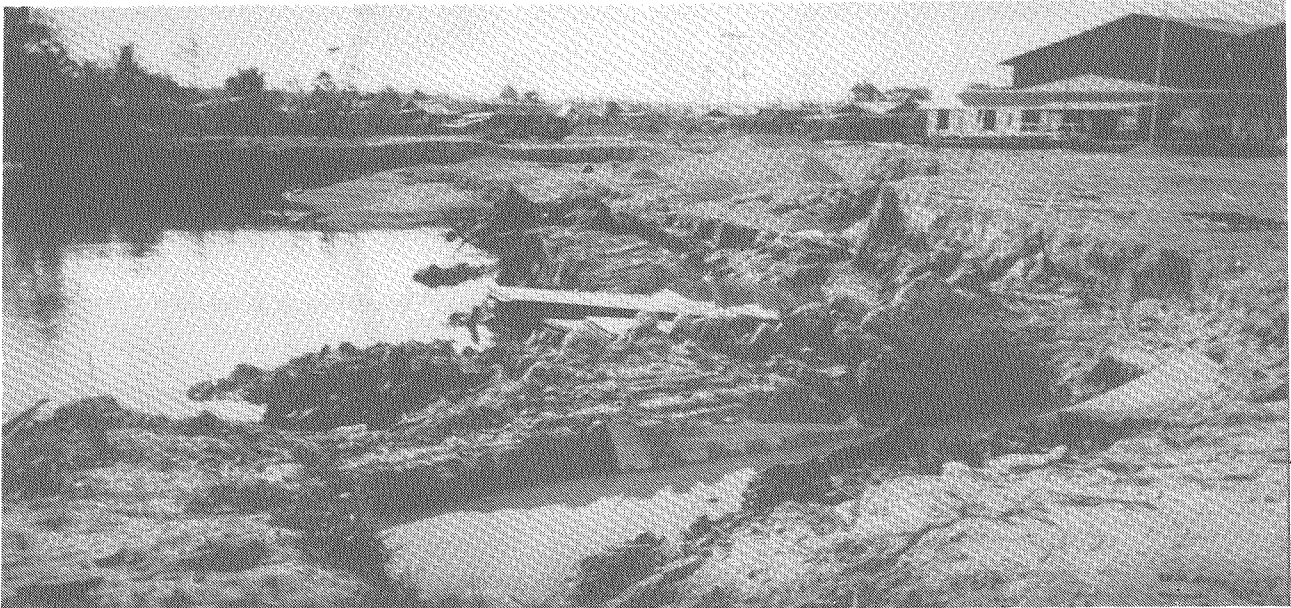
Photograph 1 View of part of slip area - river is to left of photo.

- 1 The slip occurred over a 75m length of the bank and extended some 50m back from the timber retaining structure.
- 2 The slip was on the outside of a gentle bend in the river where the natural below-water bank is quite steep, averaging about 25° to 40° between about 3m and 12m below water level.

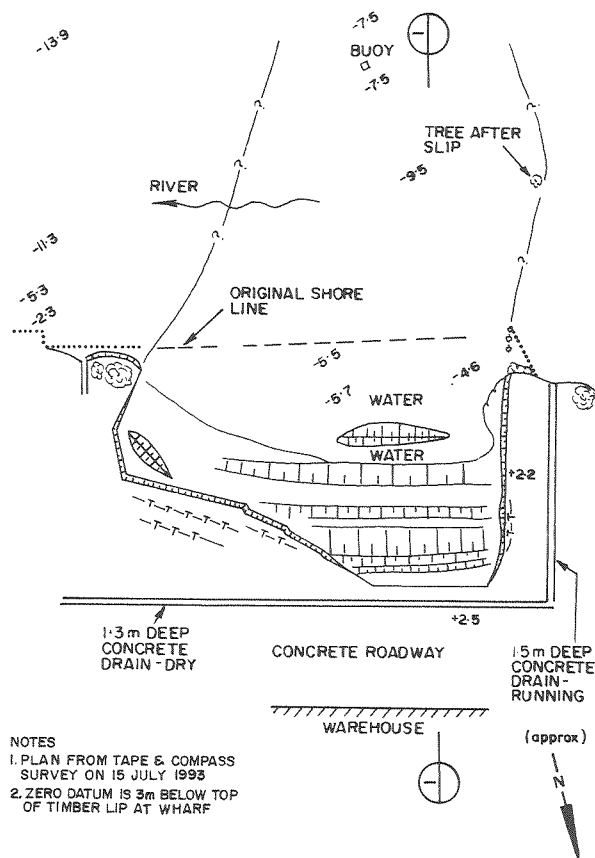
Figure 2 Plan of slip area.

A sketch plan and interpreted cross-section are given in Figures 2 and 3 . Photograph 1 shows a view of the failure. The plan is based on a tape survey and the section on depth measurements made by the author from a small boat and from ground level measurements made relative to high tide. Subsurface interpretation is based on:

- 3 Upstream and downstream of the slip area the water depth was about 11m to 13m at high tide, in front of the slip the water depth was between 5m and 9m (average 7.5m) over the full 100m width of the river.

- 4 A large dead tree, which prior to the slip was on the edge of the bank at the upstream edge of the slip, had been displaced some 30m into the river, but remained vertical. Immediately upstream of the tree the water depth was 11.5m, while a short distance downstream of the tree it was 8m.

- 5 A large crane which was being used for off loading precast piles from the Java Walrus, together with the truck it was loading, dropped vertical several metres and was moved sideways about 25m into the river. The crane remained vertical.

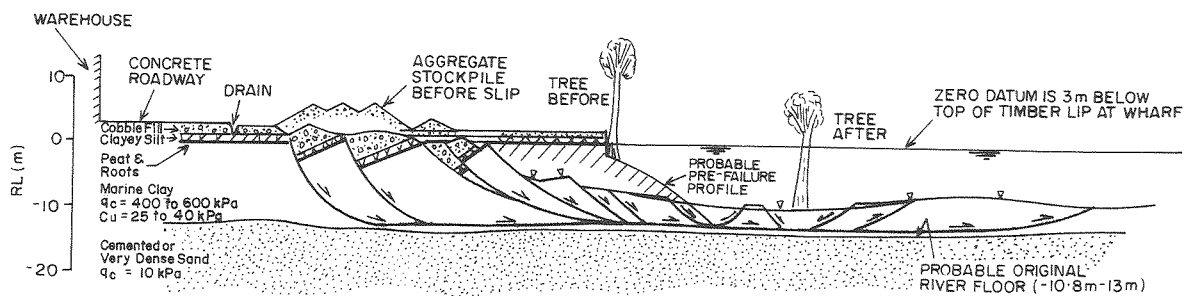
Figure 3. Interpreted cross-section through slip

- exposures of the upper 2.2m of the profile in the sides of the slip, and
- extrapolation of borehole and Dutch Cone data from a site investigation conducted in 1987 approximately 300m downstream of the slip.

- **Fill**, 0.9m to 1.2m thick, comprising cobbles and river gravel in a sandy clay matrix, overlying
- **Clayey Silt**, about 1m thick, grey, firm and overlying
- **Peat and root mat**, at least 200mm thick (the profile below this was under water)

- **Marine silty clay**, soft to firm, brownish grey, extending to between 13m and 14m below hardstand level, overlying
- **Cemented sand** or very dense clayey sand, having cone tip resistance values above 10MPa.

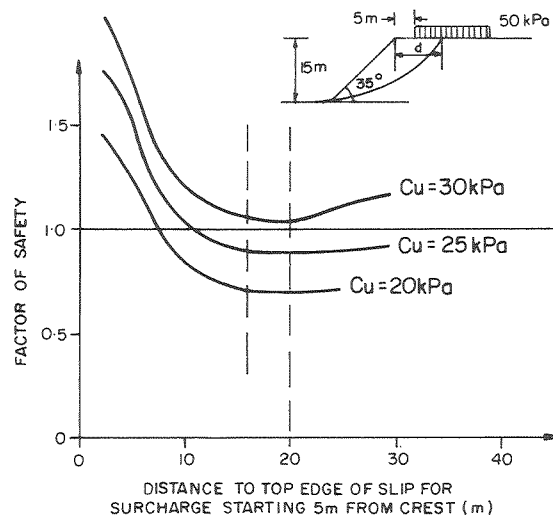
Figure 4 Analysis of the slip

There is no doubt that failure was caused by the surcharge loading. Analyses were performed using 2D slip circles and a 3D limit equilibrium method (the program INSLOPE developed by the US Bureau Mines) for different surcharge loadings and clay shear strengths. The results are summarised in Figure 4. This figure shows that a Factor of Safety of less than 1.0 would be expected given the peak undrained shear strengths interpreted from the Dutch Cone data and the actual surcharge pressures. However, the point of this note is not to record such a simple conclusion but to point out that normal stability analyses would not have given any indication of the extent of the slide. In fact the analyses would have suggested that failure should only have affected the immediate river edge.
