JOURNAL OF THE CONSTRUCTION DIVISION

REINFORCED ROCKFILL FOR CONSTRUCTION FLOOD CONTROL

By Philip J. N. Pells¹

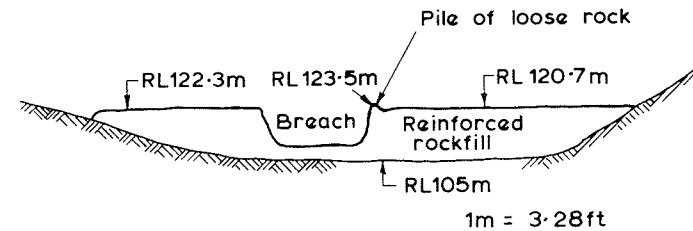
The river started to rise rapidly at 6 p.m. and by the early hours of the next morning water was flowing nearly 13 ft (4 m) deep over the top of the completed reinforced rockfill, representing a flow of about 40,000 cu ft/sec (1,100 m³/s). The uncompacted rockfill on the right of the central pile was eroded and washed down the face, cutting the mesh and stripping the 0.28-in.

(7-mm) diam horizontal wires. This allowed erosion and sloughing of the rockfill in the face, a process that gradually worked back in the form of a channel. Further flow concentration thus occurred and by the time the flood subsided a breach had been carved about 33 ft (10 m) deep and 100 ft (30 m) wide, as shown in Fig. 2. About 30,000 cu yd (23,000 m³) of reinforced rockfill and 17,000 cu yd (13,000 m³) of unprotected rockfill were lost out of the total of 300,000 cu yd (230,000 m³) placed at that stage.

One other point of importance is that the lower, left hand section of the embankment, which in fact took the brunt of the flood, did not suffer much damage. Only near the center of the valley to the left of the large pile of rock had some of the compacted rock been eroded and washed down the face, cutting portions of the mesh in the lower layers.

FIG. 2.—Bridal Drift-Downstream Elevation after Flood

The result of the failure at Bridle Drift was that considerable care was taken during the subsequent construction to remove the possibility of loose rockfill

being washed down the protected face and therefore damaging the weldmesh. The construction procedures are described elsewhere (2) and need not be repeated here. The Bridle Drift dam was completed without the occurrence of further major construction floods and thus the system was not tested. This carefully controlled construction sequence was written into the tender documents for the Xonxa dam for which also a reappraisal of the design of reinforced rockfill was undertaken.

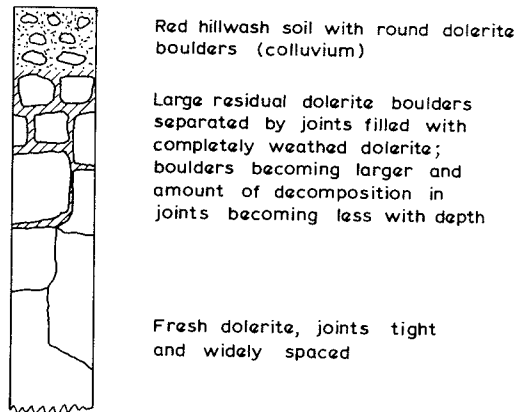
The site is at a point where the river flows through a very short gorge associated with a major dolerite intrusion. The river floor and lower portions of the right flank consist of massive fresh dolerite at the surface. However, the left flank can best be described as consisting of a classic dolerite residual profile as shown in Fig. 4. The problem was the difficulty in defining, from the limited borehole data available, at what depth one was out of residual "boulder" formation and into sound dolerite. This problem was to play a large part in the subsequent failure.

FIG. 4.—Idealized Geological Profile of Left Flank at Xonxa

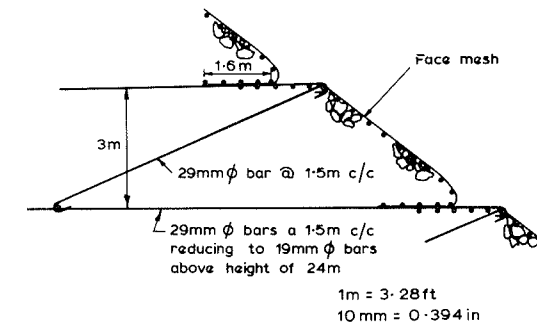
FIG. 6.—Reinforcing System Designed for Rockfill at Xonxa

The anchorage system designed for Xonxa is shown in Fig. 6. This involved a considerable decrease in the quantity of anchorage steel from that used at Bridle Drift. The heaviest layers of anchors consisted of 1-1/8-in. (29-mm) diam bars at 5-ft (1.5-m) centers, compared with 1-1/2-in. (38-mm) diam bars at 9-in. (0.23-m) centers used at Bridle Drift.

When construction at Xonxa got underway the contractor considered that the oblique bars shown in Fig. 6 could not be placed satisfactorily and these were simply incorporated with the horizontal anchor bars.

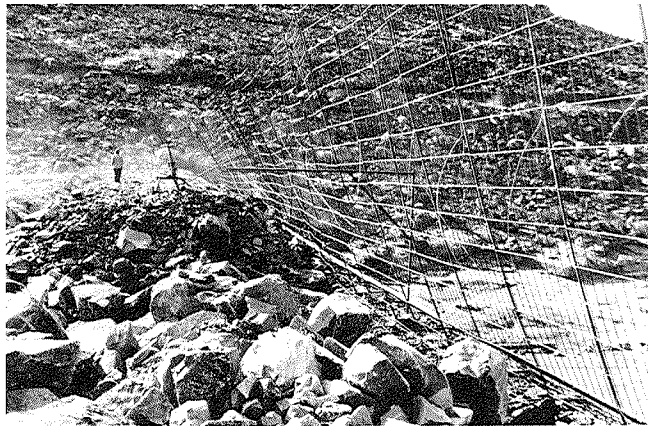
FIG. 7.—Rockfill Being Placed Behind Prefabricated Mesh Panels

the downstream edge of the previous layer prior to any further rockfill being placed, as shown in Fig. 7. The rockfill was advanced against the panels usually working from one flank, although it had originally been planned that work should proceed from both flanks. The idea of the prefabricated panels was that in the event of a flood occurring at any stage during the placement of a 10-ft (3-m) lift, the panels could be bent back and secured to the anchor bars lying on the preceding compacted layer. The layers were not in fact horizontal but sloped upward at about one in 20 in the downstream direction, thus minimizing the tendency for any overtopping flood to transport rock over the protected downstream slope. Although a fair amount of hand work was involved in the final finishing of the downstream face, the construction system worked well.

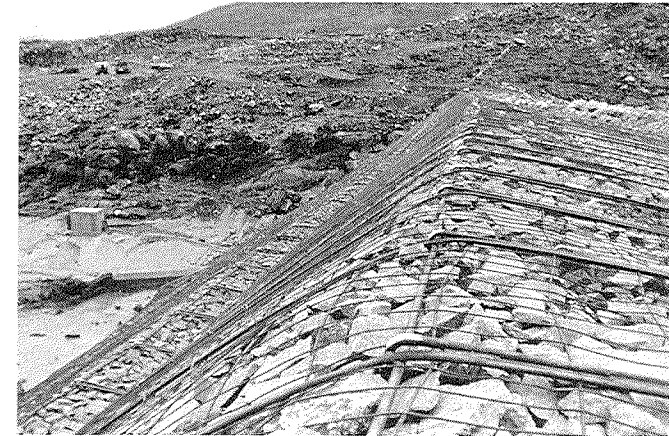
Fig. 8 shows the reinforced rockfill prior to the major flood. There was, however, one problem associated with the reinforcement, which was what to do at the flanks. As with most embankment dam design the reinforcement at Xonxa was designed in terms of a two-dimensional slice taken through the embankment in the center of the valley. Sufficient consideration was not given

during the design to the three-dimensional problem where the downstream face meets either valley side. On the site the problem was "solved" by suitably bending the panels under the ends of each layer. On the right flank the panels at the end of each layer were placed on and doweled to the fresh dolerite

FIG. 8.—Reinforced Rockfill Prior to Flood

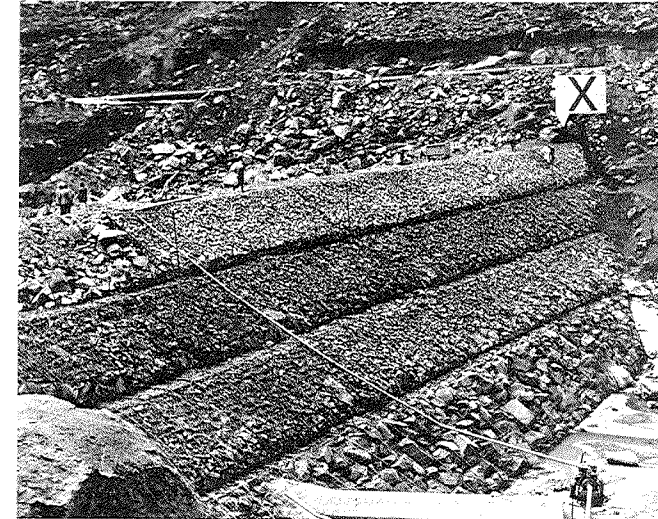
FIG. 9.—View of Left Flank During Placement of Fourth Layer—X Marks Residual Dolerite "Boulders" to which End Panels of Next Layer Were Fixed

that was virtually at the surface. However, on the left flank, above a height of about 20 ft (6 m) the panels under the end of each layer were placed on and doweled to what later were shown to be huge residual dolerite "boulders." The photograph in Fig. 9 shows the situation during the placement of the fourth

layer and shows the boulders (marked with an X) on the left flank to which the end panels of the next layer were fixed. It can be seen that no protection was provided for the natural hillside material downstream of the face on the left flank. At the time of the flood a further three lifts of rockfill had been placed and the top of the rockfill was level with the high level outlet that can be seen on the left flank in Fig. 9.

Thus under full overtopping there was considerable diagonal flow down both flanks. On the left flank this flow rapidly removed the loose rocky topsoil and then started eroding into the massive residual dolerite "boulder" formation. It appears that the huge "boulders" to which the left end of the fifth rockfill layer was fixed (marked with X in Fig. 9) were undercut on the downstream side and plucked out. Since the end mesh panels were fixed to these boulders with grouted dowels a hole was torn in the mesh. Once a large rip occurred in the face mesh, progressive failure could take place rapidly. Rockfill eroded out of the hole and the material in the higher layers collapsed downwards and was washed away until a slot had been formed to the surface. Flow then concentrated at the left flank and the slot was progressively deepened and

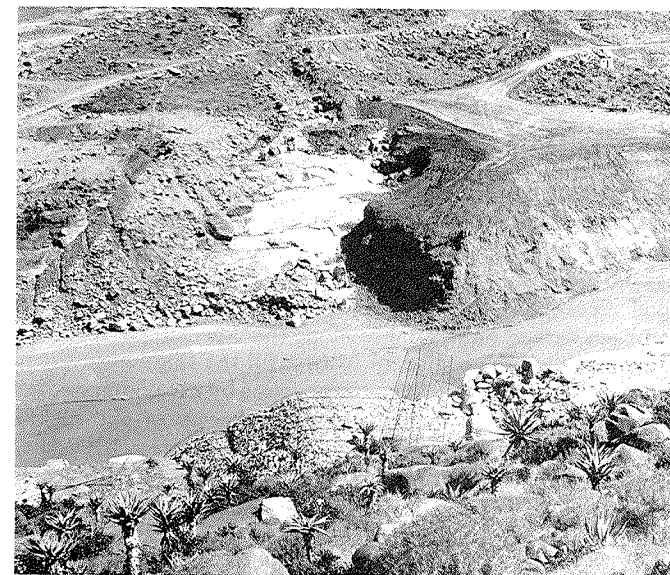
Unfortunately, because all the site personnel lived in Queenstown, about 25 miles (40 km) from the site, and because the unsurfaced access road became almost impassable due to flooded creek crossings, only two people witnessed the full overtopping of the embankment. The first was the contractor's mechanic who succeeded in reaching the site and saw that full overtopping had developed and that the reinforced rockfill was showing no signs of distress. He then left the site. The second person was the local missionary who made his way to the site somewhat later in his Landrover and took some 8 mm cine film of the full flood pouring over the reinforced rockfill. By this time there had been full overtopping for about 12 hr and the reinforced rockfill was showing signs of distress on the left flank. Night fell and by next morning the embankment had been devastated, as shown in Fig. 10. About 75% of the rockfill and 65% of the compacted earthfill had been washed away.

The mechanism leading to the collapse became apparent when the cine films taken by the missionary were examined. At the time of overtopping the crest length along the downstream edge of the reinforced rockfill was about 560 ft (170 m) while at the toe of the dam the valley is about 130 ft (40 m) wide.

FIG. 10.—View from Left Flank after Flood

then widened towards the right flank. In fact it appears that most of the rockfill was washed somewhat diagonally from behind the still intact reinforcement out through the gap rapidly enlarging from the right flank.

Reconstruction.—The effect of the water sweeping through the breach in the rockfill was to scour the right flank down to fresh dolerite bedrock to an elevation of 50 ft (15 m) above the river bed. This scouring revealed quite clearly the depth at which one passed from residual dolerite "boulder" formation into what can be termed bedrock, something that was not easy to determine correctly from the borehole data.

Reconstruction was carried out using the same reinforcing system used originally. The big difference was that since the left flank had been scoured down to dolerite bedrock the ends of the layers could be satisfactorily constructed with there being no possibility of undermining.
