Copeton Dam: Performance of the Great Scour Case Study in the floods of 2022

Steven Pells¹, Alex Duwell², Hetal Parmar³.

Erosion of the spillway at Copeton Dam in the 1970's captured worldwide attention. Much was published about the unexpected erosion, although studies considered only geological factors. Some remedial works were implemented, but erosion remained a critical concern. This paper provides an overview of historical scour issues including recent studies which considered hydraulic analysis and scour modelling.

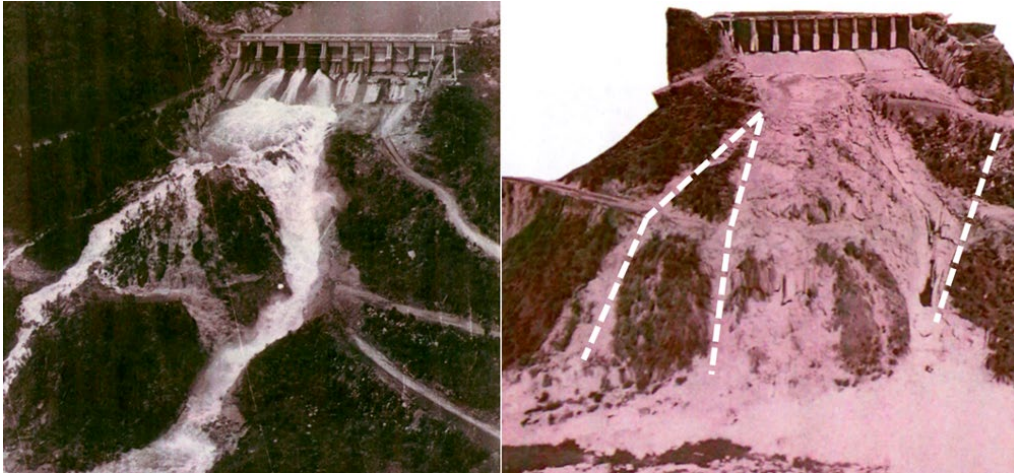
Figure 2 – Photographs of the spillway during and after the 1976 flood events. Weathered overburden was widely removed (right), and water falling into the natural gully (left) caused extensive erosion and formation of a deep slot. Some of the erosion has been interpreted to follow shear zones (right - white dashed lines)

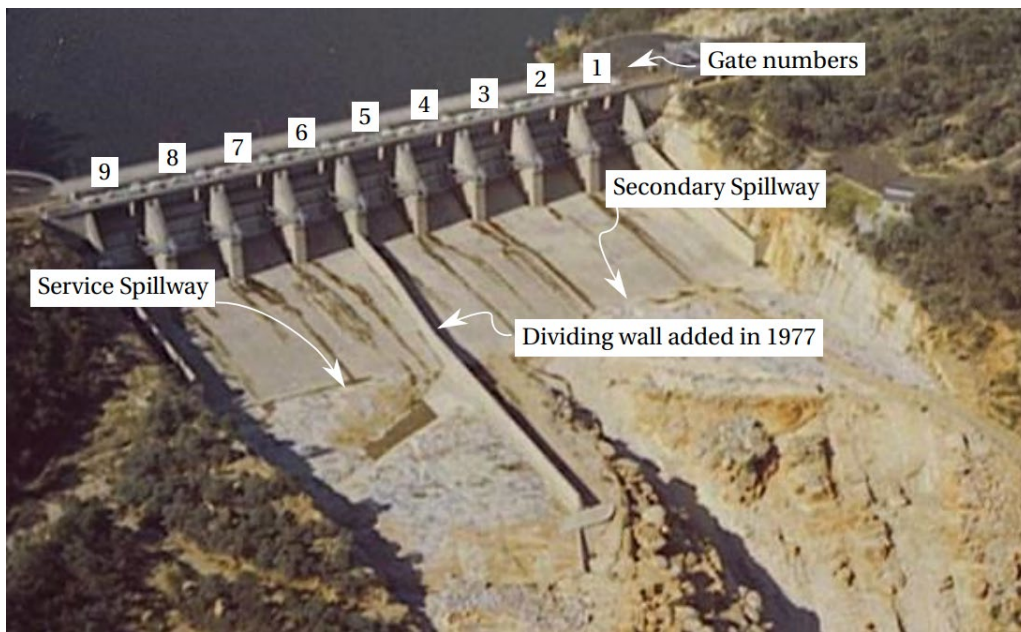
Figure 3 – Division of the spillway into Service and Secondary. Erosion was primarily in the (now) secondary spillway. Note repair work (‘swimming pool’) at the end of the slab in the Service Spillway.

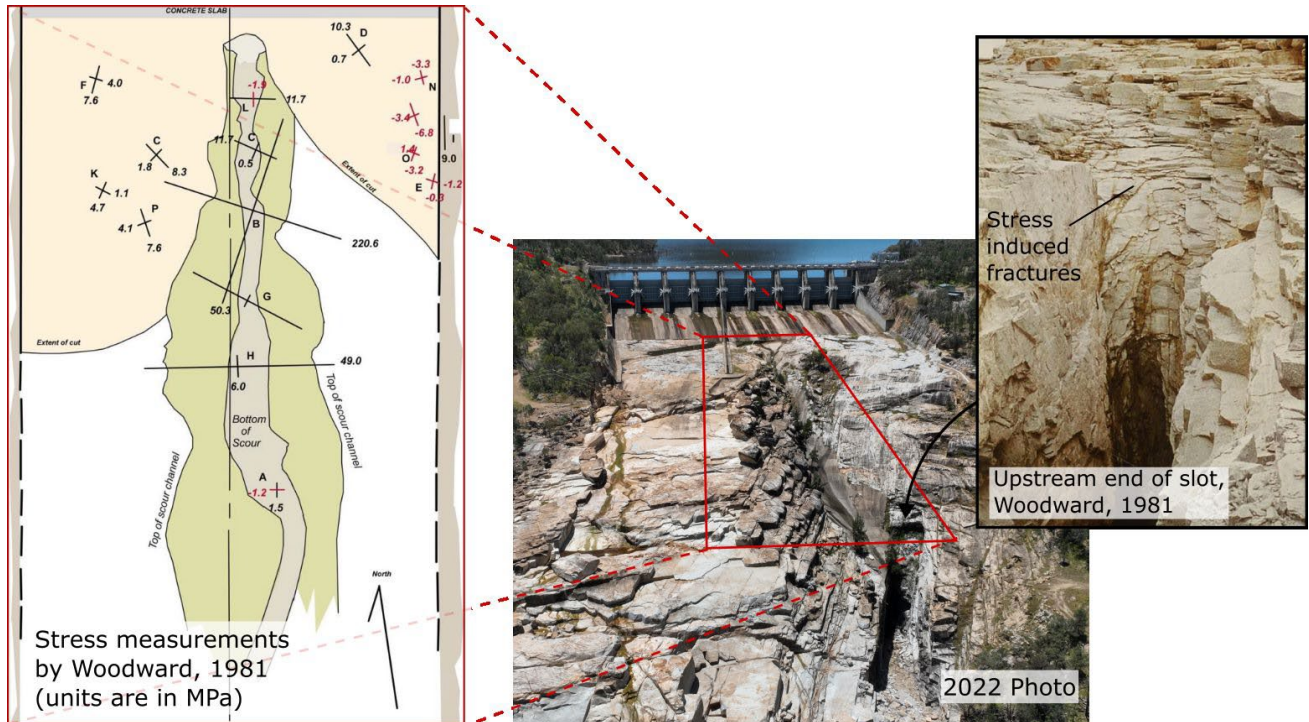
The erosion risks at Copeton Dam have attracted many technical studies since 1976. Earlier studies focussed exclusively on the geological facets of erodibility, noting regular subvertical joints and persistent horizontal sheet joints that arise from very high *in-situ* stresses over the entire spillway domain. The resulting large blocks of rock can be mobilised from hydraulic forces which penetrate the vertical defects and can slide and roll the blocks along the sheet joints. Examination of the large gully below the secondary spillway noted that *in-situ* stresses of 10 to 50 MPa (and larger) within the bed of the gully are of similar magnitude to the UCS of the rock mass, exacerbating closer sheet joint formation within the gully and associated smaller block sizes which may be more easily mobilised (Figure 5).

Figure 5 – Geomechanical mechanisms related to high in situ stresses have been interpreted to exacerbate scour

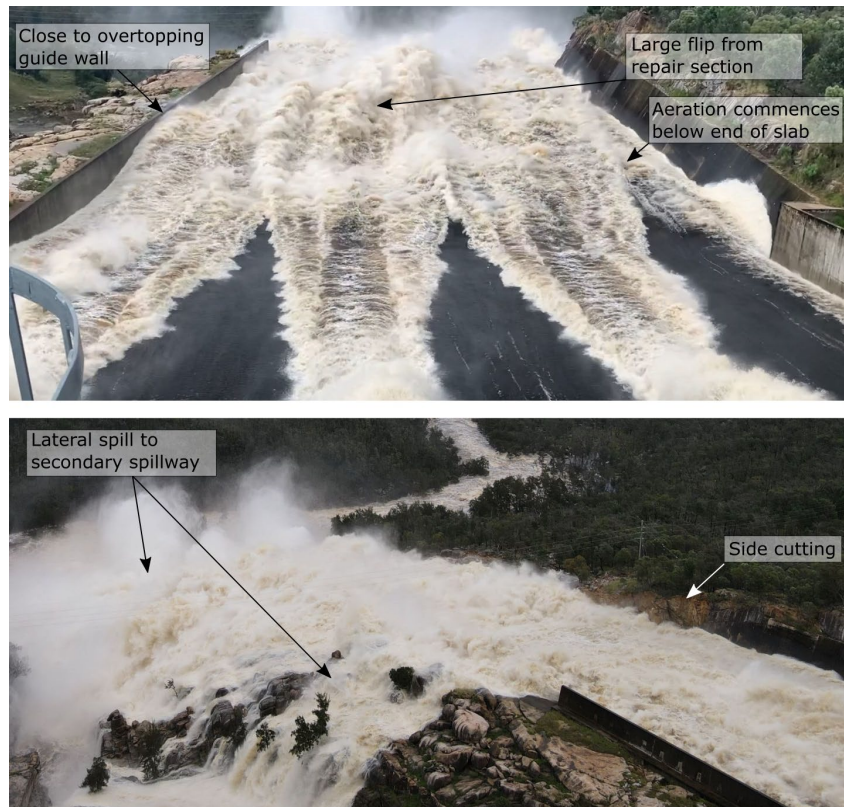
Photographs taken by WaterNSW during the peak flow are shown in Figure 10 with annotations highlighting some observations. The guide wall that defines the left-hand side of the Service Spillway appears to nearly overtop under flows of 1700 m³/s, and it therefore appears likely that it would be subject to significant overtopping from design flows, which are over 3 times greater. The orientation of the concrete works below the apron (the ‘swimming pool’) flip the flow upward and are evidently subject to very high energy. Lateral flows below the guide wall spill onto the Service Spillway. Under higher discharges, higher lateral flows would be expected. Whilst high energy supercritical flows are largely unable to turn a corner to follow an identified fault below the end of the right-hand wall, lateral spill is still likely to increase under higher flows.

Figure 10 – Photographs during peak flows in the October 2022 spill event

1. The guide wall that defines the left-hand side of the Service Spillway appears to nearly overtop under flows of 1700 m³/s, and it therefore appears likely that it would be subject to significant overtopping from design flows, which are over 3 times greater.

2. Photos of the 2022 flows shows that concrete repair works just downstream of the apron (the ‘swimming pool’) flip the flow upward and are evidently subject to very high energy. The orientation of these concrete works suggests that they cover-over a lower quality rock mass associated with a geological structure. Failure of these concrete repairs would expose the lower quality rock masses and be subject to high hydraulic energy, and therefore likely result in serious erosion near the structure and associated serious consequences. Risk assessments should consider review of the details of these repair works.

3. Lateral flows below the guide wall spill onto the Service Spillway over a region of rock mass which is perceived to be vulnerable to erosion, due to open subvertical fractures which run parallel to a steep slope, and sheet jointing that dips toward the steep slope. Under higher discharges, higher lateral flows may mobilise this rock, causing erosion and potentially undermining the end of the guide wall – which would in turn increase lateral flows and further erosion.

4. Significant undercutting of the slope below the end of the wall on the right-hand side of the spillway is observed, which appears to be at the head of a previously identified fault line. Whilst high energy supercritical flows are largely unable to turn a corner to follow this fault, lateral spill is still likely to increase under higher flows. Ongoing erosion here may progress upstream into the flow field, capturing more flow and potentially causing development of a gully along this geological structure that could potentially advance further the flow field.

1. raising of the guide wall to prevent overtopping during design flows.
2. review of the details of design and construction of repair works below the apron slab (the 'swimming pool') and, if necessary, assessment of its adequacy against hydraulic forces from the design flows. Consideration may be given to augmentation of these concrete repairs to increase their strength and to reduce the 'flipping' effect on flows, which may promote overtopping of the guide wall.

3. extension of the guide wall to lower lateral overflow onto the secondary spillway
4. extension of the right-hand side concrete wall to protect against further bank erosion and potential erosion along fault structures.

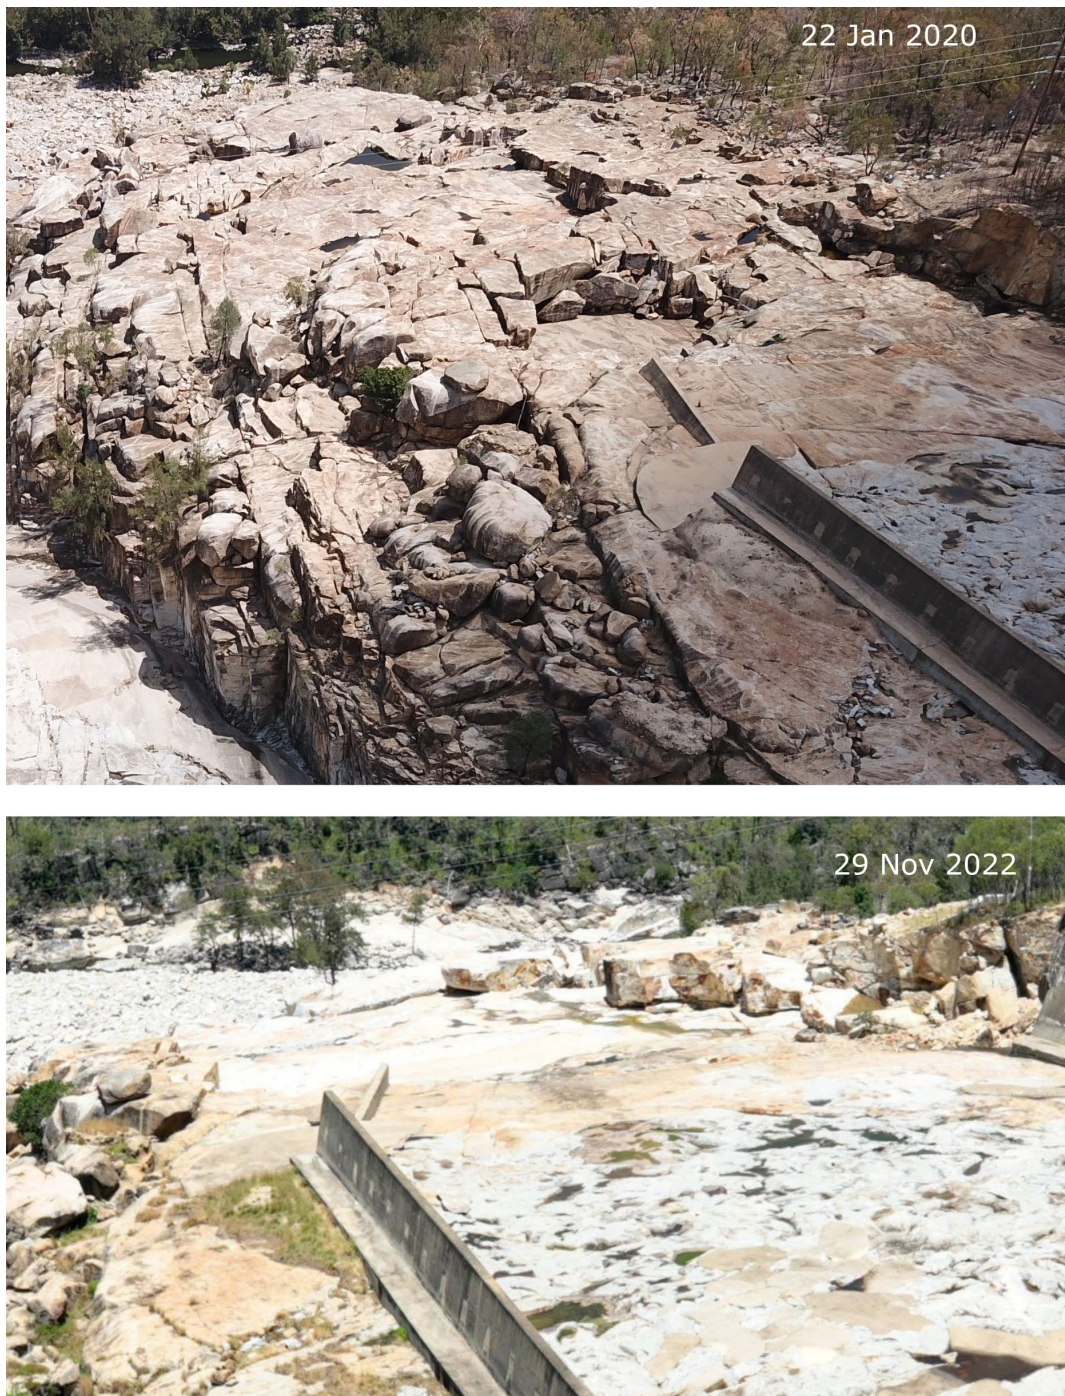
The rock mass within the excavated section of spillway (i.e., just below the apron) has previously been interpreted to be a Laumontite region of the granitic mass, and subvertical defects are less apparent, being either absent, less frequent, or more tightly welded. These characteristics create a mass of arguably higher erosion resistance. Numerous patches of dental concrete have been placed around this region, and erosion here comprised small locations of plucking out of isolated blocks.

Figure 11 – Oblique photos from Jan 2022 (top) and Nov 2022 (bottom)

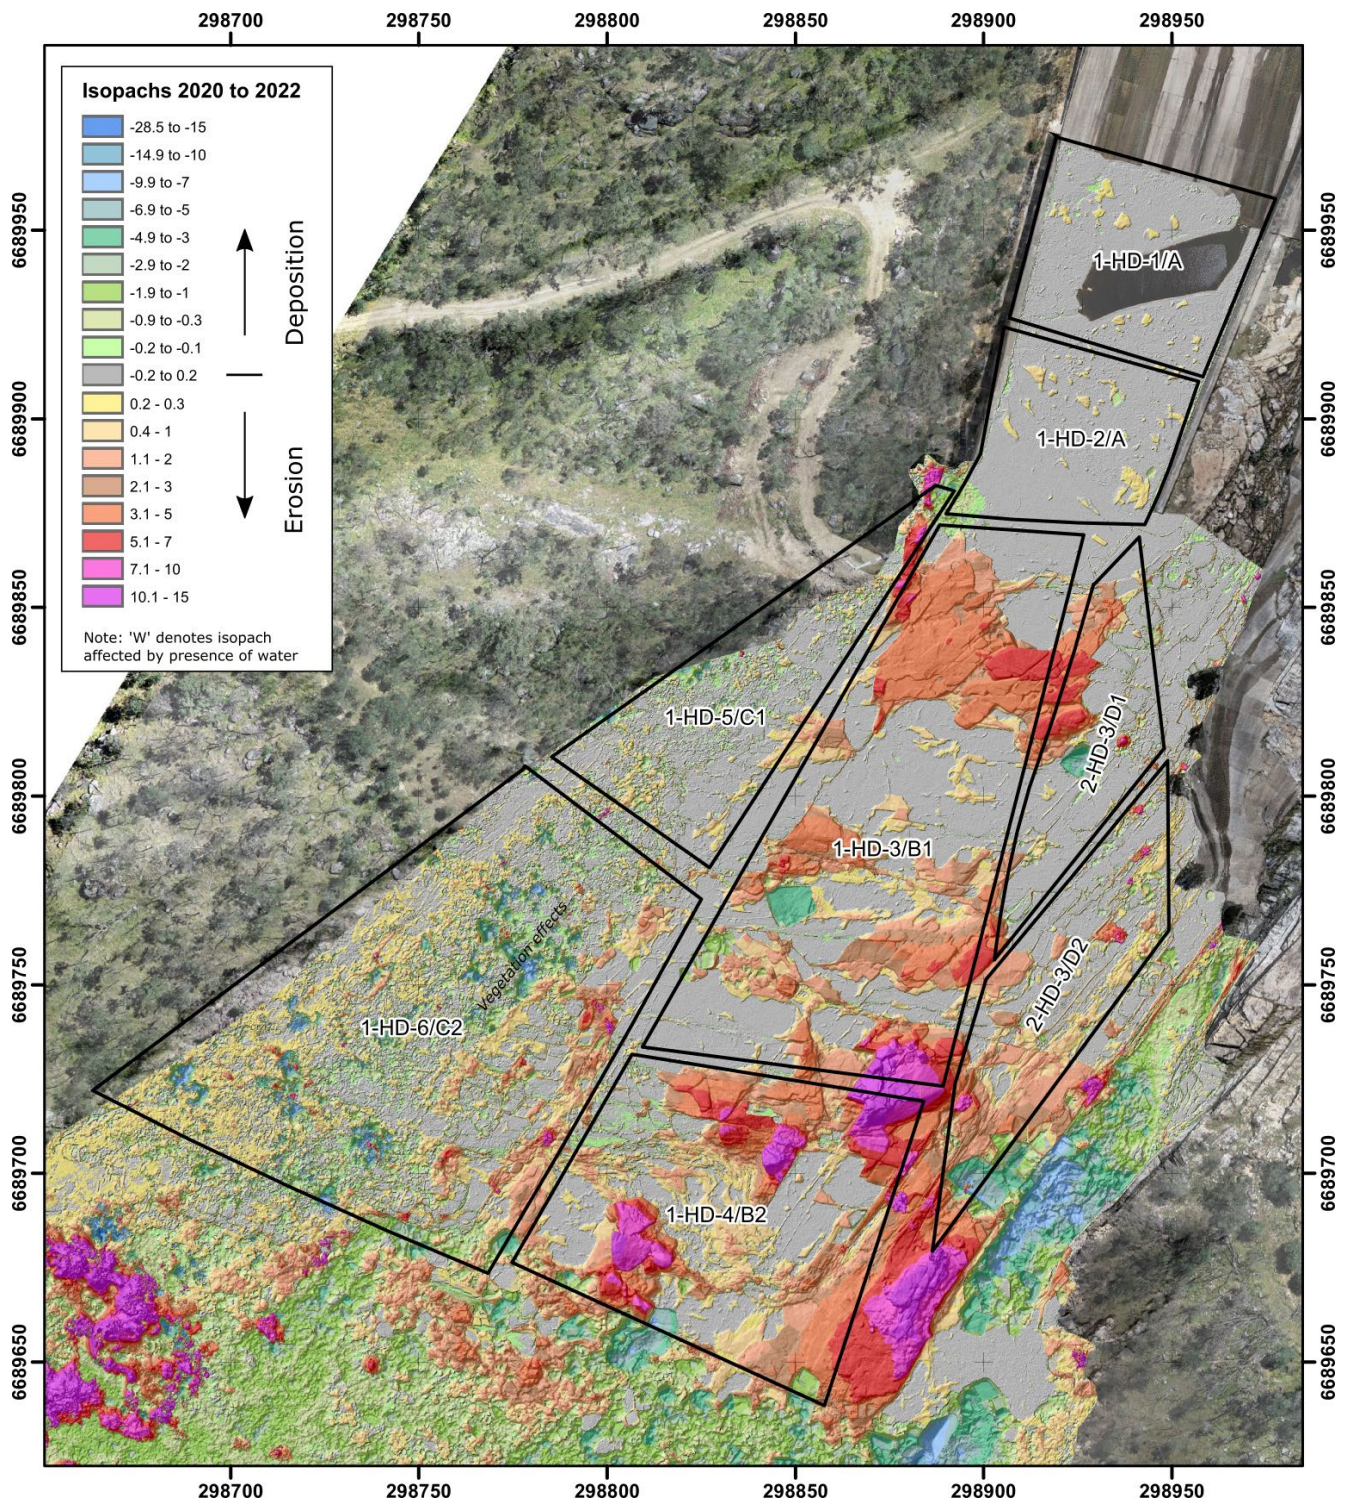
Topographic surveys and aerial photographs were acquired using Unmanned Aerial Vehicles (UAV's) on 24 January 2020 and November 2022. The 2020 survey used photogrammetric techniques to resolve detailed topography, whereas the 2022 survey used Lidar techniques. Both surveys recovered detailed aerial photographs, and both were undertaken by HELImetrix (www.helimetrix.com.au). An oblique photo from each date presented in Figure 11 shows that large, loose blocks that were present in 2020 were swept away during the 2022 spills. An isopach map was calculated as the mathematical difference between 2020 and 2022 ground surface, which clearly highlights where erosion has occurred, as shown in Figure 12.

Figure 12 – Erosion isopachs, 2020 to 2022

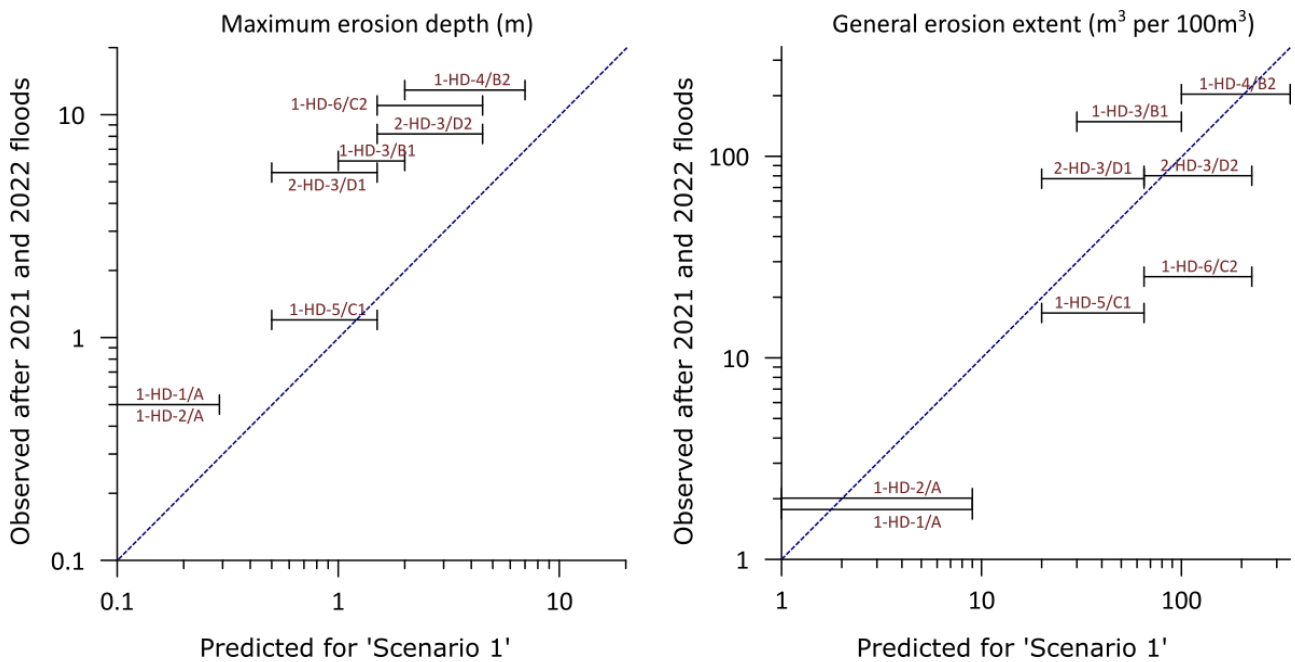
Scour risks assessments made in PSM 2021 chose a discharge condition for Scenario 1 that happens to be representative of the October 2022 event – see Figure 7. This provided the opportunity to review the accuracy of the past assessment, conceding that observed erosion arises from a suite of events between November 2021 to November 2022 and not just from the October 2022 event. The 2021 analysis defined a series of ‘scour domains’, which are the polygons shown in Figure 12. A scour domain is a region that is interpreted to have common geological qualities and common hydraulic loading characteristics. For each scour domain, an ‘erosion vulnerability class’ was determined, based on geological and hydraulic analyses and application of the Pells 2016 method. Each of these classes are associated with erosion quantities, as presented in Table 1. For comparison, the measured erosion quantities from analysis of Figure 12 are also presented. The results are also presented graphically in Figure 13.

Figure 13 – Observed erosion from 2022 versus predicted erosion for ‘Scenario 1’

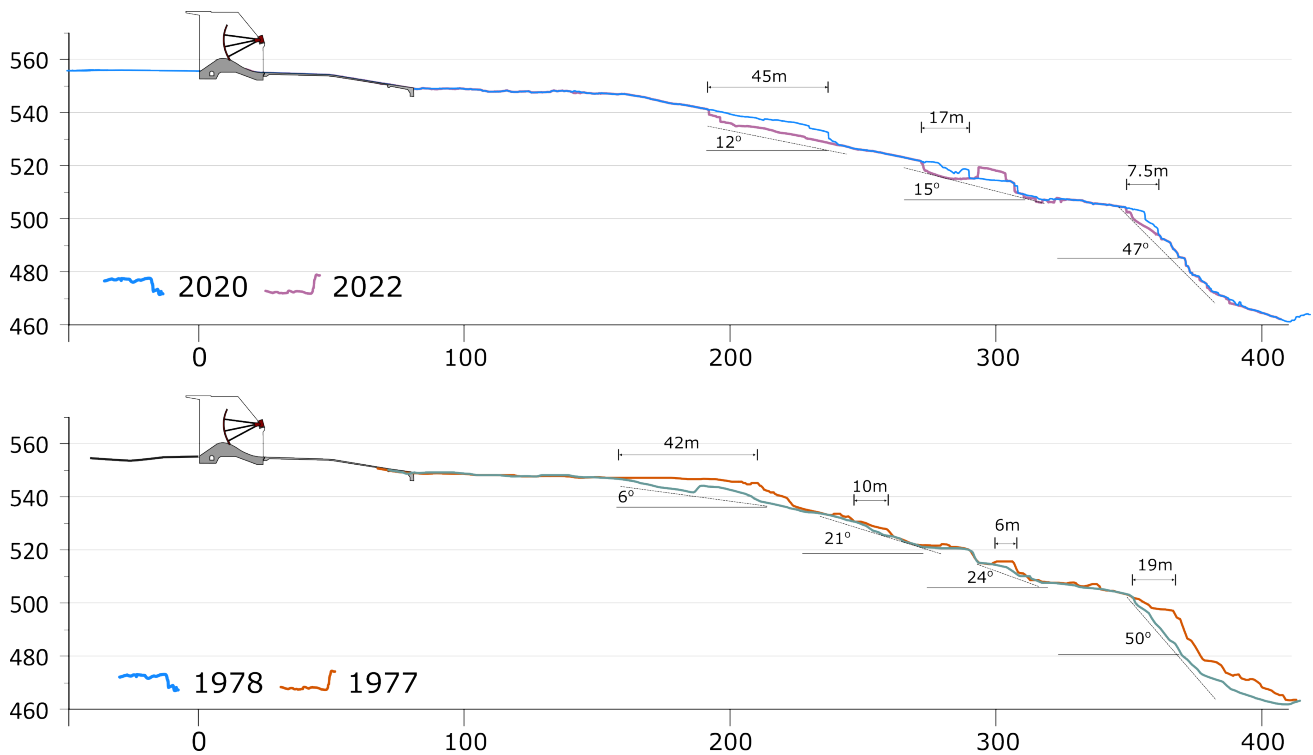
Figure 15 – Example of estimates of headcutting between sequential ground surveys

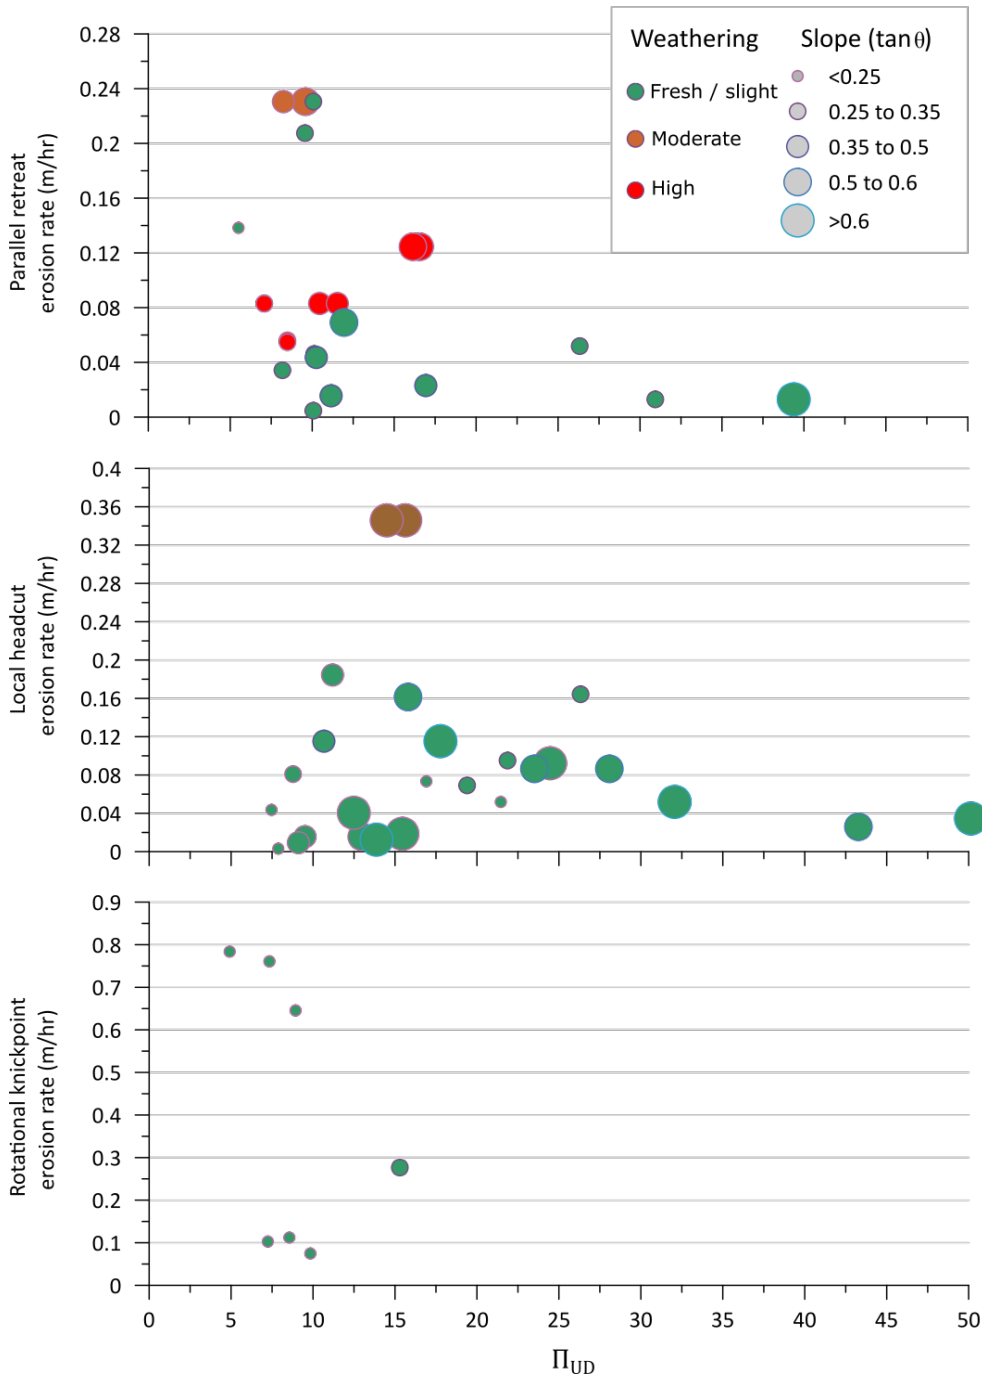
Plots showing the results are presented in Figure 17. It is noted that the data is noisy, as may be expected by the nature of the interpretation and as is often the case for headcut data. There is a paucity of such data published, and these plots at least provide some approximate point of reference.

Figure 17 – Dataset of interpreted headcut rate (m/hr) versus unit stream power dissipation (kW/m²)

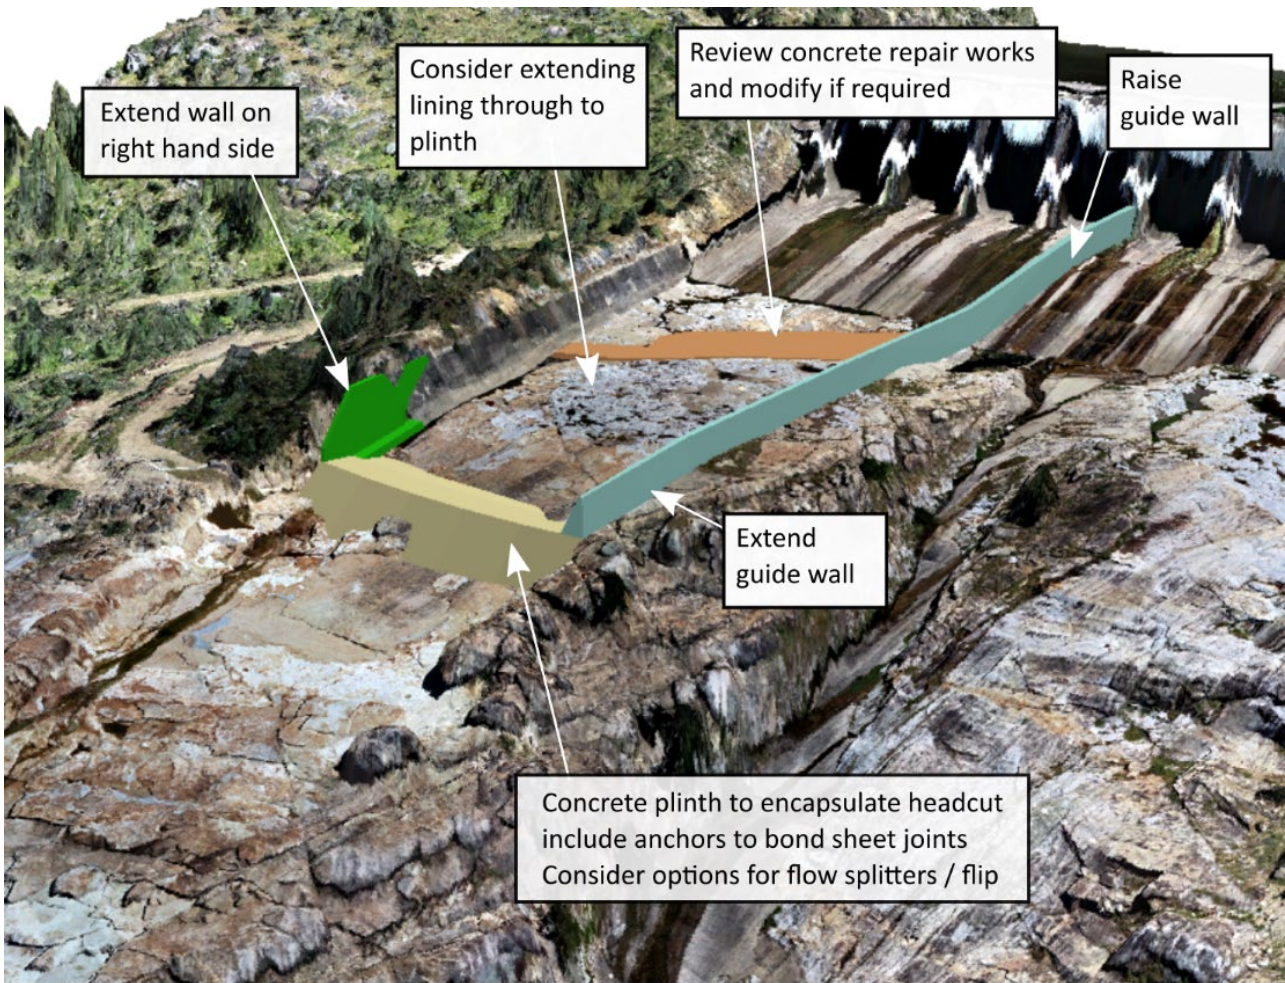
Figure 20 – Concept of works to reduce erosion risks

Concepts for design works to decrease risks from erosion of the Service Spillway have been proposed for further discussion and review. Works that may be considered are shown conceptually in Figure 20 and include:

5. construction of an anchored concrete plinth at the end of the excavated section, at the location of the current headcut, to discourage further upstream movement of the headcut (Figure 21). Consideration may be given to addition of flow splitters / flip buckets to promote flow energy dissipation.

In consideration of these works, it may be pragmatic and reasonable to consider extension of the apron slab up to the location of the proposed concrete plinth, so that all the new concrete works can be tied in together. It is also noted that spot-erosion within the excavated section was higher than expected, and this alone may warrant consideration of an extended slab.

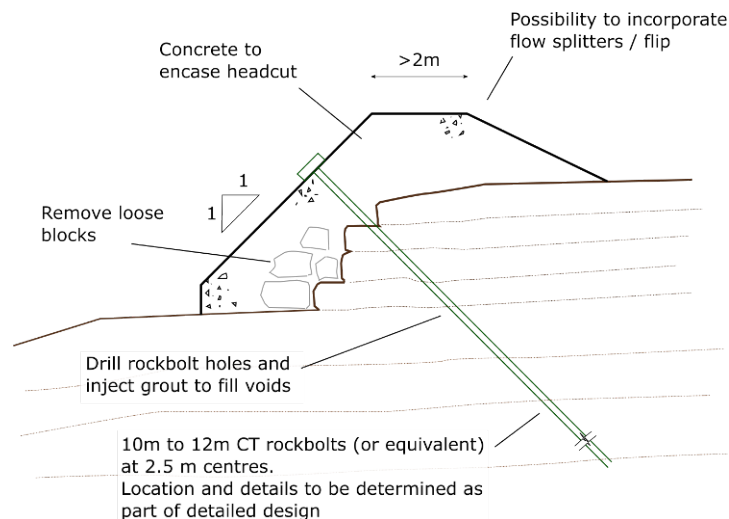
Figure 21 – Concept of plinth to control headcutting
