HYDRO-GEOTECHNICAL ROCK SCOUR ASSESSMENT AT PETIT-SAUT DAM

Summary. This paper presents a recommended design procedure for assessment of rock scour which is illustrated for the case study of Petit-Saut Dam in French Guiana. The methodology, referred to as a "hydro-geotechnical scour assessment", promotes a multi-discipline approach, applying expertise in both rock mechanics and hydraulics, and guides the diagnosis of scour and response to risk by application of currently available scour assessment techniques.

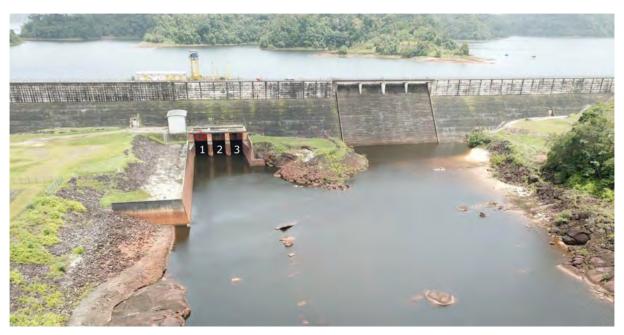
Figure 4: View of bottom outlet (showing numbering convention) and overflow spillway (1 July 1995)

numbering convention as shown in Figure 4. Each gated outlet is 7 m width and 6.7 m high. Flow is controlled by sluice gates – there is an upstream guard gate (usually open) and a downstream service gate, which is manipulated to control flows. Whereas the power station discharges are released into a constructed tailrace, flows from the bottom outlet are released to the right bank of the original river channel. A concrete wall retains earth and rock materials on the right bank for a distance of approximately 80 metres downstream of the bottom outlet, as seen in Figure 4.

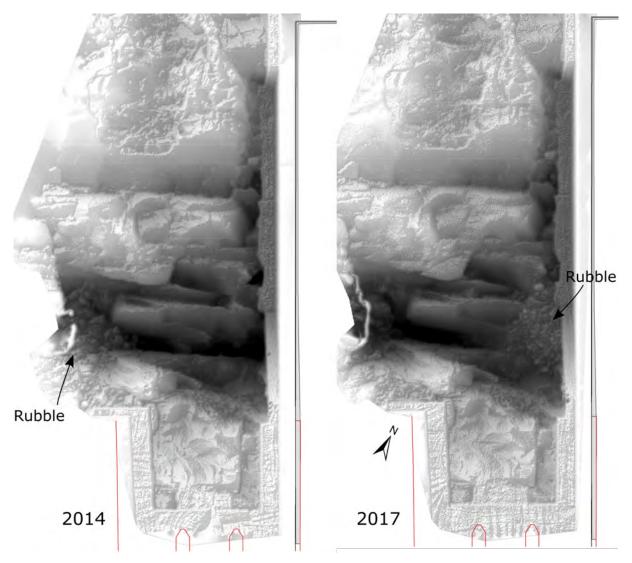
Figure 5: Hill-shade perspectives of bottom outlet bathymetry, November 2014 and November 2017

As-constructed ground surveys have not been sourced, but it is assumed that, at commissioning, the floor of the chute downstream of the bottom outlets was set at approximately 0m NGG, in accordance with designs. Two bathymetric surveys have since been undertaken, being in November 2014 and November 2017. The bathymetric surveys were rendered as hillshade rasters in Figure 5 below. Long- and cross-sections through the bottom outlet are shown in Figures 6 and 7, respectively.

- The November 2014 survey reveals erosion that has occurred over the 20-year period since commissioning of the dam. This erosion arose from 12 flood seasons and the flood-of-record release in 2000.

- A large scour hole has developed, which has a shape that clearly reveals that rock mass has been removed between persistent subvertical and upstream-dipping joint sets, which strike perpendicular to the flow direction. The upstream dipping defect-surface is interpreted to be sheet-jointing. The remaining rock mass has the appearance of fresh granite, and it is postulated that the scour hole shape reflects the extents of a deeper but localised weathering zone, as is commonly observed in granitic formations.

- Erosion against the retaining wall has revealed the wall footing, reflecting preferential operation of Gate 1 prior to 2014 but may also have been facilitated by rock-mass disturbance from excavation for the wall footing.

- A pile of loose rubble located at the left bank is visible in the 2014 survey, interpreted to be derived from erosion extending laterally into the left-hand bank (Figure 8). In the 2017 survey, the rubble adjacent to the left-hand bank was removed with a corresponding accretion of rubble at the right bank in the 2017 survey. This is considered to be relocation of the same rubble by circulation patterns following the preferential operation of the left-hand gate (number 3) since the 2014 survey.

- Comparison between the November 2014 and November 2017 surveys indicates that little additional erosion of the rock mass occurred, despite the occurrence of significant flows.

Ongoing monitoring of the rock mass downstream of the bottom outlet was recommended. This would comprise repeated bathymetric surveys after two or three significant flow events. Surveys should endeavor to assess the extent of undermining of the wall footing.

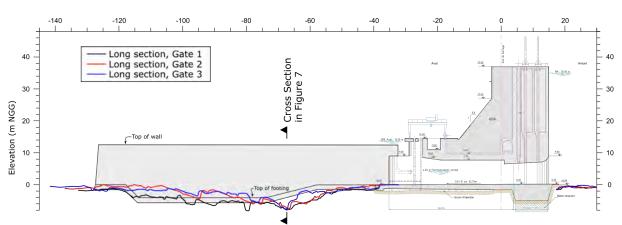
Figure 6: Long section through bottom outlet, 2014 elevation

- The erosion profile in Figure 6 follows the decline of the wall footing, which may indicate the profile of competent rock, as sought and encountered during construction of the wall.

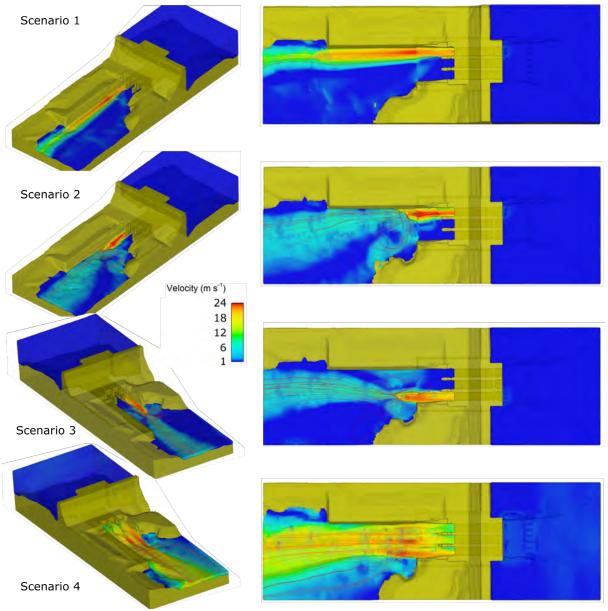
Figure 9: Flow velocity and patterns from CFD modeling

- Releases from the Gate 1 with the as-constructed topography show the high-velocity jet remaining close to the wall and extending over the excavated section without entering a hydraulic jump. This, along with the possibility of disturbed rock mass adjacent to the retaining wall toe due to excavation for its footings, may explain the elongated extent of erosion observed adjacent to the retaining wall.

- With development of a scour hole, the extent of high velocity flows and high energy dissipation is shortened, and focused onto the upstream region.
- The locations of peak hydraulic dissipation are similar for flows from the left hand and right hand gates. The peak hydraulic dissipation extends from the end of the concrete lining and over the upstream edge of the bed-slope descending into the scour hole.

- At many locations, larger discharges associated with wider gate openings do not appear to result in higher unit stream power dissipation values, as the energy is dissipated over a longer distance.

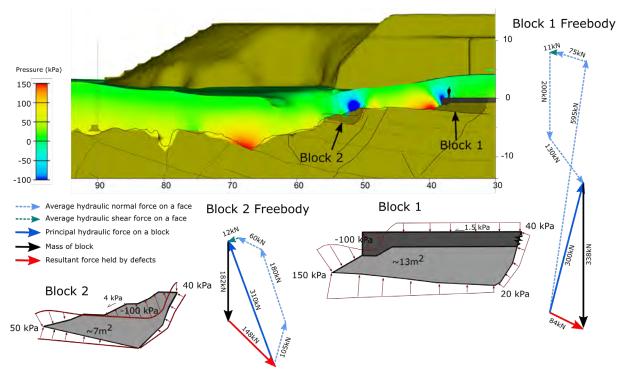
Figure 16: Example of kinematic analysis of selected blocks

Freebody diagrams were used to explore the kinematic stability of selected "blocks" across the spillway. Figure 16 shows example blocks and their associated stability freebodies, through incorporation of surface pressures predicted by the CFD model, and interpretation of the possible propagation of such pressures into defects in a manner similar to experimental results observed in Pells (2016). The estimated uplift force on Block 1 is exceeded by the mass of the block suggesting that the block is kinematically stable under mean pressures. For Block 2 a more tenuous condition is seen, with a restraining force in excess of 148 kN required from strength of the defects to maintain stability. As hydraulic pressures are subject to fluctuation, larger pressure pulses potentially apply an impulse into defects, and have the capacity to displace the block, albeit momentarily. A timescale of gradual dislodging of the block is thus inferred by the passage of multiple pressure fluctuations over time.

These 2D free-bodies are approximations, but illustrate the perceived nature of erosion: the current scour hole is considered to be stable against sudden and widespread erosion, but the persistent fluctuating hydraulic conditions have the potential to incrementally strain blocks, ultimately allowing liberation of key blocks. This could then trigger further scour in episodes from time to time.
