The influence of geological conditions on erosion of unlined spillways in rock

Kurt Douglas^{1*}, Steven Pells², Robin Fell¹ & William Peirson³

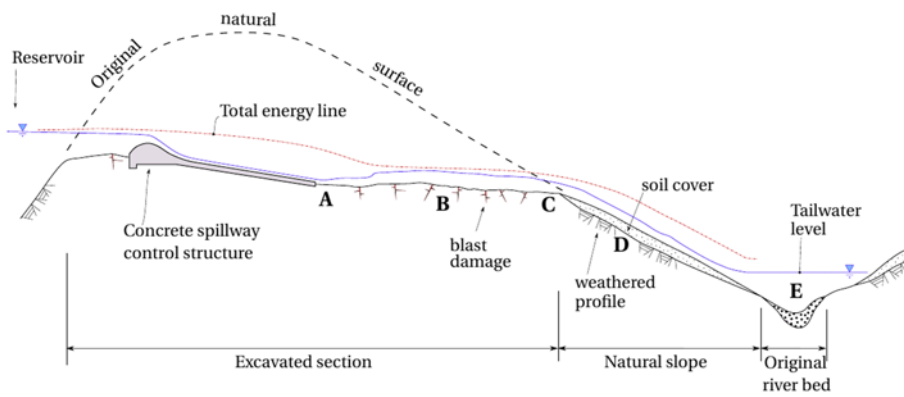
Fig. 1. Conceptual cross-section through side-channel spillway (adapted from Woodward 1981).

In Figure 1 a conceptual cross-section through a typical side-channel spillway chute is shown. Typically, the side-channel chute is excavated through the ridge or abutment adjacent to the dam. The chute typically has a gradient $<10^\circ$. A concrete sill is usually constructed to control the reservoir level and discharge characteristics, and an initial section of the spillway may be lined so that the possibility of erosion is moved away from the control section. A flip bucket will often be placed at the end of the lined section (not shown). The excavation will typically 'daylight' on to a natural slope, where flows are directed back to the original river bed. The areas marked A to E in Figure 1 are discussed in turn.

A. The smooth lined section facilitates development of high-velocity flows with relatively small head losses (the gradient

of the total energy line takes a long distance to approach the gradient of the channel). These high-velocity flows strike the unlined section at point A (or slightly further downstream if a flip-bucket exists) and rapid energy dissipation occurs (the total energy line steepens) over the sudden change in roughness. These flow conditions may induce erosion at point A, particularly where the rock has remnant damage from the blasting for the spillway chute excavation. This erosion may be a hazard to dam safety if a plunge pool or head cut develops, which begins to progressively undermine the lined chute.

- B. The excavated, unlined, section of spillway at point B may have a lower gradient and higher roughness, causing slowing and deepening of flows, reducing the erosive power. However, some transport of remnant blocks or blast-damaged rock may occur, and further erosion may develop depending on the geological conditions exposed below. The rock mass defects that control erosion are bedding (if present); joints of tectonic origin; and shears and faults, often with associated closer jointed rock adjacent.
- C. Point C marks the knickpoint between the end of the excavated section and the start of the natural slope. The hydraulic conditions here are also transitional, with the gradient of the total energy line steepening in the approach to the steeper natural slope. Upstream migration of this knickpoint is possible if head cutting occurs.

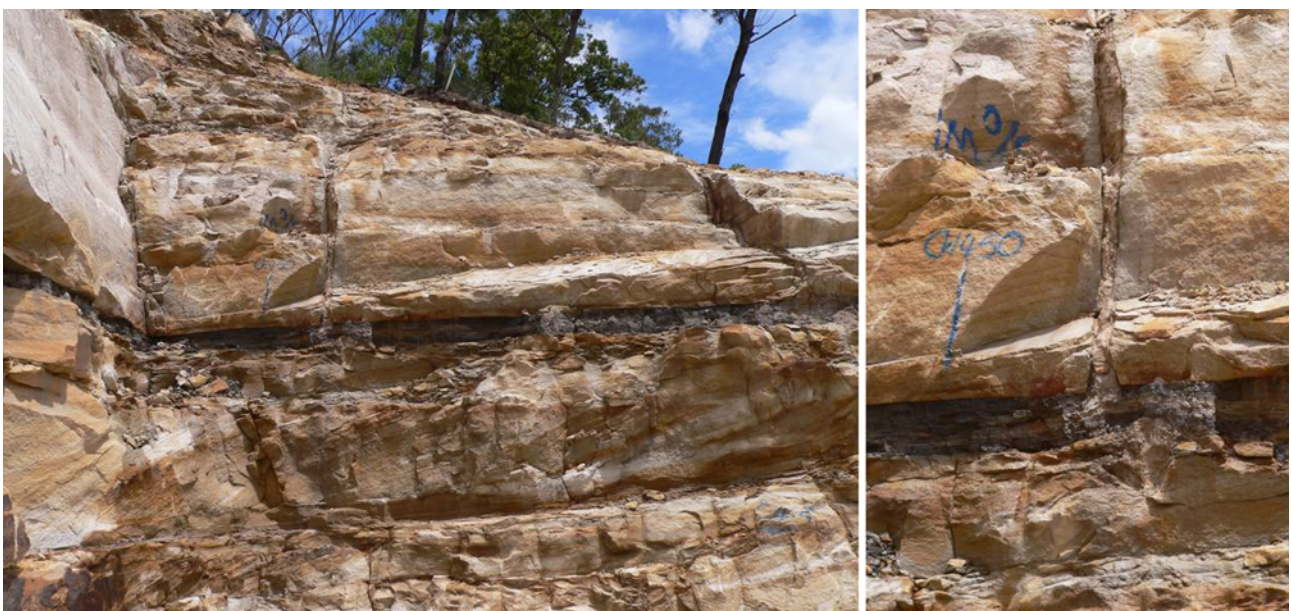
Fig. 2. Photographs of the abutment of Shannon Creek Dam, showing in-filled stress relief joints. The joints are up to 80 mm wide and terminate on shale beds. Photographs courtesy of L. McDonald and Clarence Valley Council (Fell *et al.* 2015).

In sedimentary rock environments, stress relief on valley formation can result in displacement of blocks of rock and open or soil in-filled joints (Figs 2 and 3). The water from the spillway may penetrate into the joints and displace the blocks by water pressure in the joint and beneath the block. The erosion may progress as head cutting, such as shown in Figure 4.

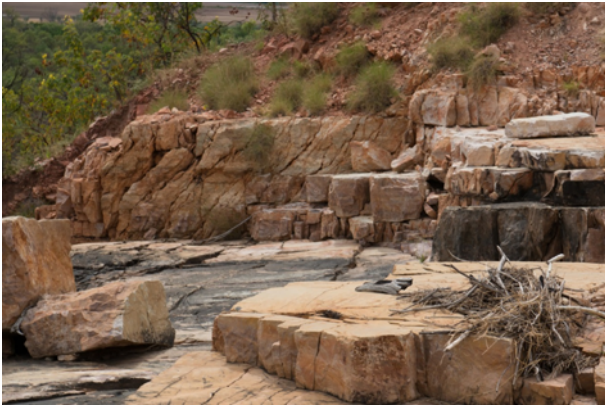
Fig. 3. Moochalabra Dam spillway showing erosion controlled by sub-horizontal bedding and valley stress relief joints in the near surface.

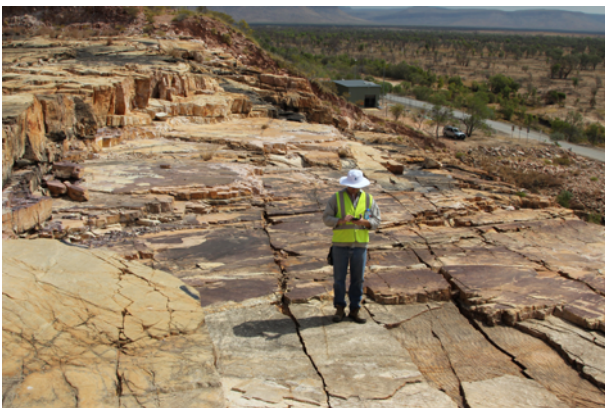
Fig. 4. Moochalabra Dam spillway showing head cutting in sub-horizontally bedded sedimentary rocks exhibiting head cutting at the downstream faces, but resistance to erosion elsewhere.

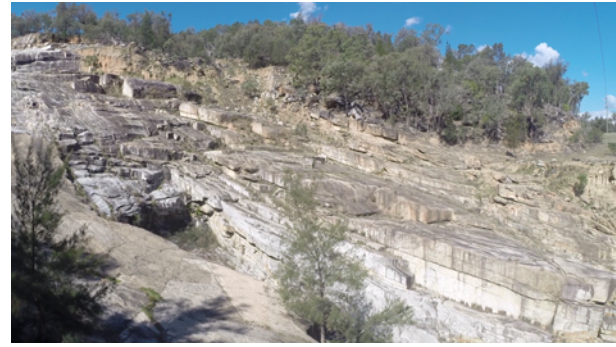
Fig. 5. Copeton Dam spillway showing sheet jointing in granite sub-parallel to ground surface controlling erosion.

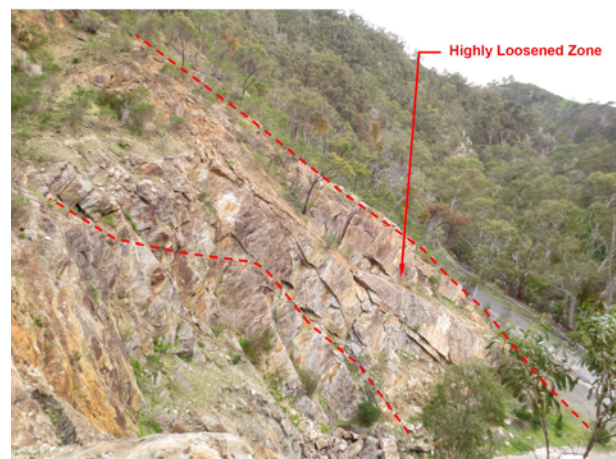
Fig. 6. Kangaroo Creek Dam site showing persistent valley stress relief sheet joints parallel to ground surface and resulting loosening of the rock with open joints. The sheet joints cross-foliation and tectonic joints within the schist and gneiss. Photograph courtesy of GHD and SA Water.

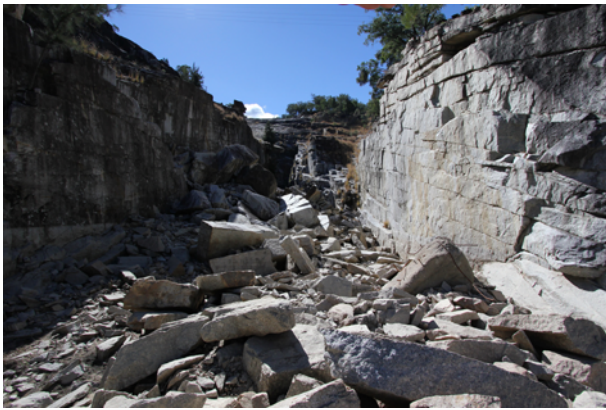
Fig. 7. Copeton Dam spillway showing deep erosion in closely jointed fault zone. Toppling observed in the photo is understood to have occurred post the spilling event. Sheet joints are shown in the walls.

- (b) Shears and areas of closely spaced joints, often associated with shears which cross the spillway channel, are susceptible to erosion and, once eroded, allow formation of kinematically viable mechanisms to displace blocks in the adjacent rock mass. Examples are Copeton and Mokolo spillways (Figs 7 and 8; Pells 2016; Pells *et al.* 2016).

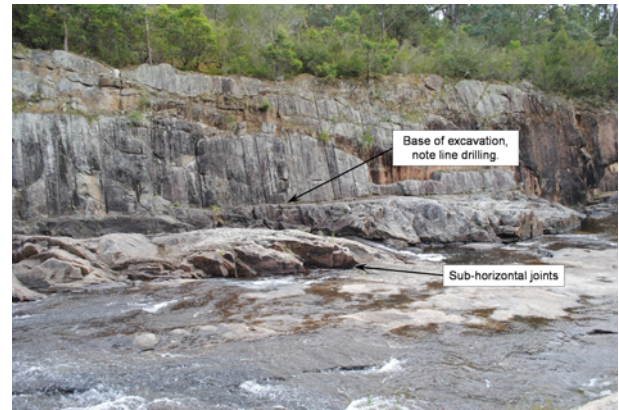
Fig. 9. Brogo Dam spillway showing erosion controlled by persistent sub-horizontal joints.

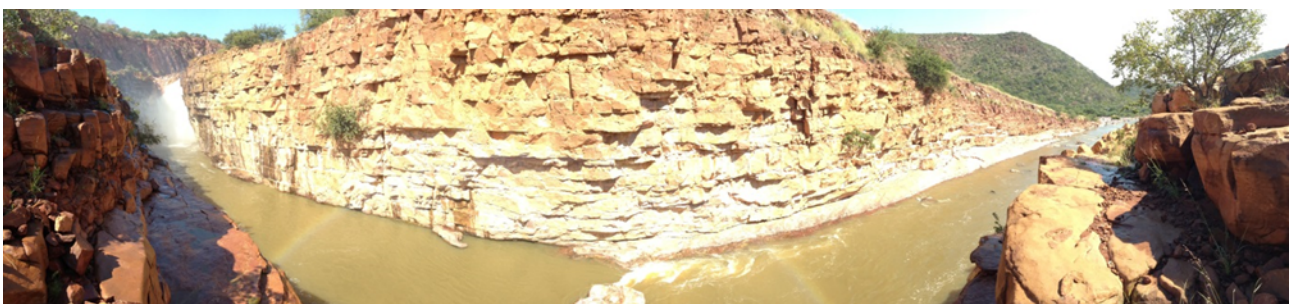
Fig. 8. Mokolo Dam spillway showing erosion up to 25 m deep in fault zone.

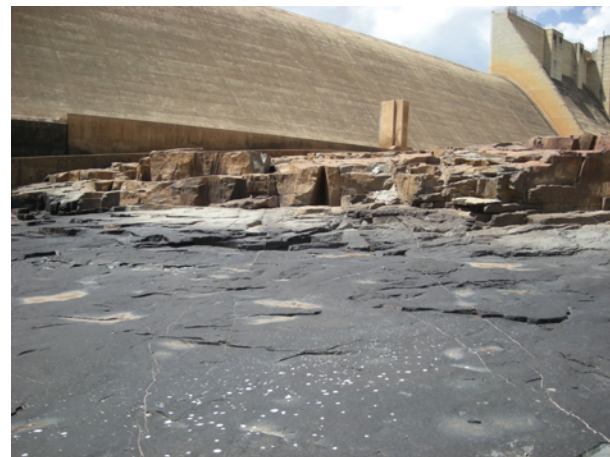
Fig. 11. Burdekin Falls spillway showing remnant jointed rock, and persistent sub-horizontal defects in ignimbrite. The non-eroded area is characterized by having widely spaced tight joints with no free faces to form kinematically viable blocks.

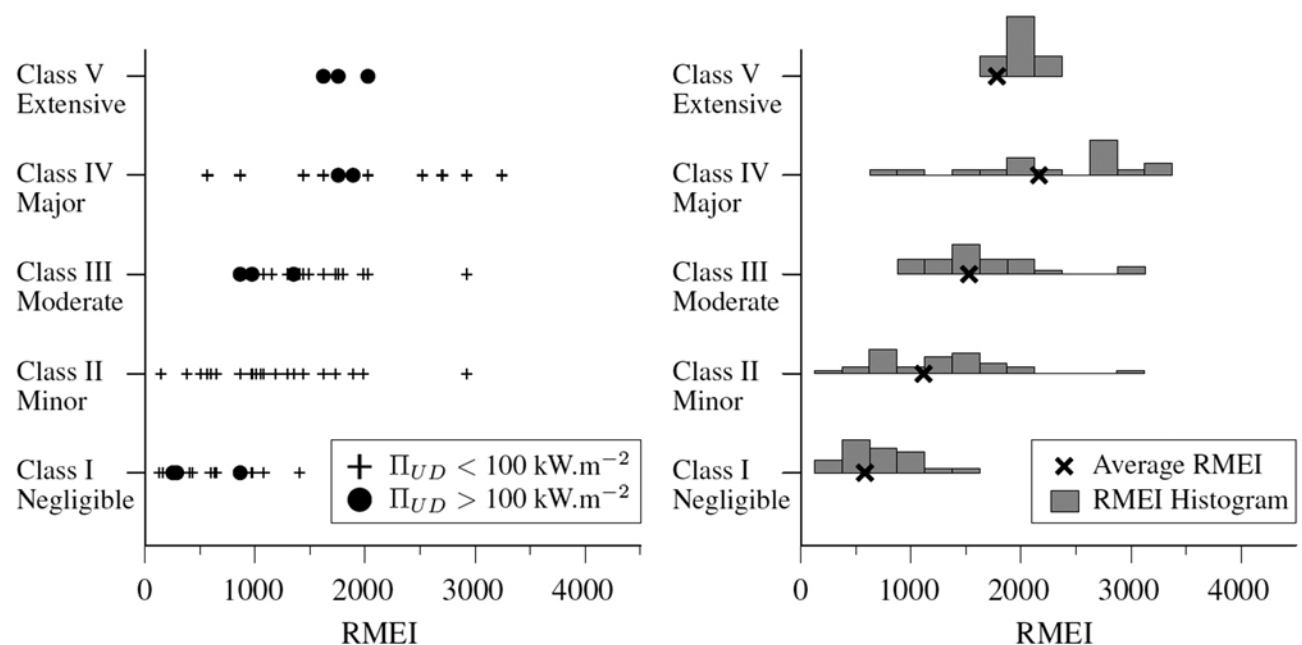
Fig. 12. RMEI v. observed erosion class.

RMEI values were assessed at erosion domains at 23 dam spillways, representing 101 data points, as presented in Table 1. A plot of RMEI v. observed erosion is presented in Figure 12. Distinct symbols are used to distinguish high stream power (Π_{UD}) case data. It can be seen that there is a reasonable correlation between the

observed erosion class and the RMEI without taking stream power into account. The exception is Class V erosion, which has three high stream power data points indicating that when hydraulic loading is high the stream loading dominates the amount of erosion over the geological factors. For lower stream power flows, it is the rock mass – as represented by RMEI – that distinguishes between large and small erosion. Rock masses may be resistant to high energy flows if no kinematically viable mechanisms for detachment exist.

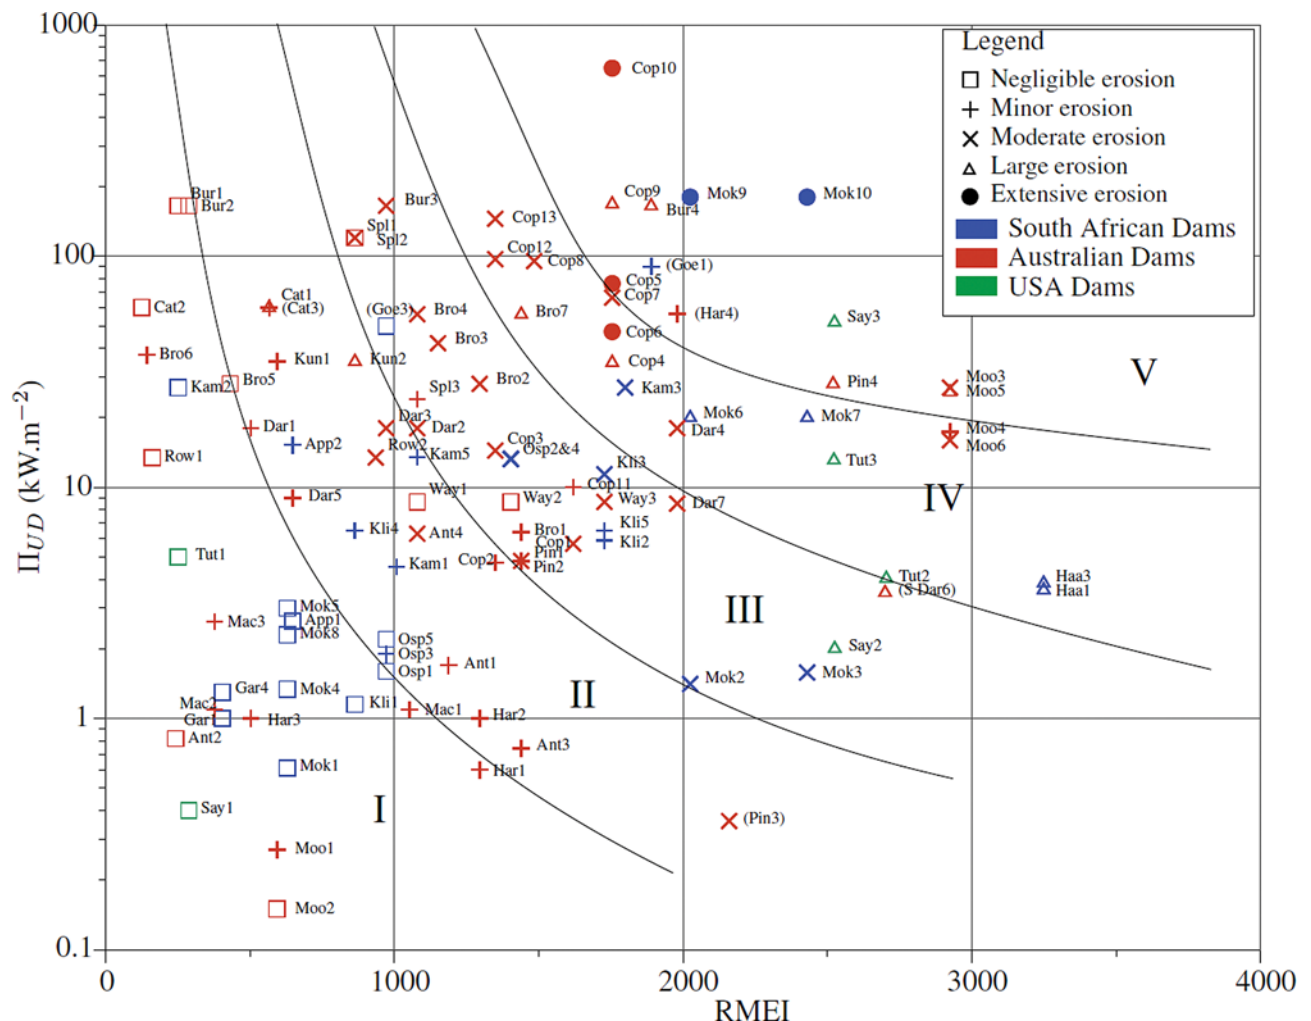
Fig. 13. Observed erosion as a function of RMEI and Π_{UD} showing erosion classes as defined in Table 2.

In Figure 13 the case study data are plotted as a function of RMEI and Π_{UD} , and contours were drawn with respect to the observed erosion class.

The erosion class contours in Figure 13 have been modified from what was presented in Pells (2016). This is to allow for the following:

- from sediment transport/geomorphological studies, the stream power associated with initiation of sediment movement is in the order of $100 W m^{-2}$. Hence the curves have been assumed to asymptote to this value even for rock with high RMEI;
- for RMEI=0, intact rock studies by Kirsten (1995) indicated values of 10 000 to 100 000 $kW m^{-2}$ for erosion of intact materials – the contours' upper range reflects this;
- the quality of the data points near the erosion class boundaries.

It can be seen that the erosion class contours correlate reasonably well with the data for erosion classes I, II and III and less so for classes IV and V. The boundary for class V is least well defined as there are fewer data points.
