RE: WAMBERAL BEACH: RISKS ARISING FROM GROUND MOVEMENT AND/OR STRUCTURAL COLLAPSE AS OF 25 OCTOBER 2025

This short report provides a technical assessment of Risks, as they existed in October 2025, along the length of Terrigal/Wamberal Beach from the entrance of Terrigal Lagoon to the Wamberal Surf Club; a beach length of approximately 1.4km.

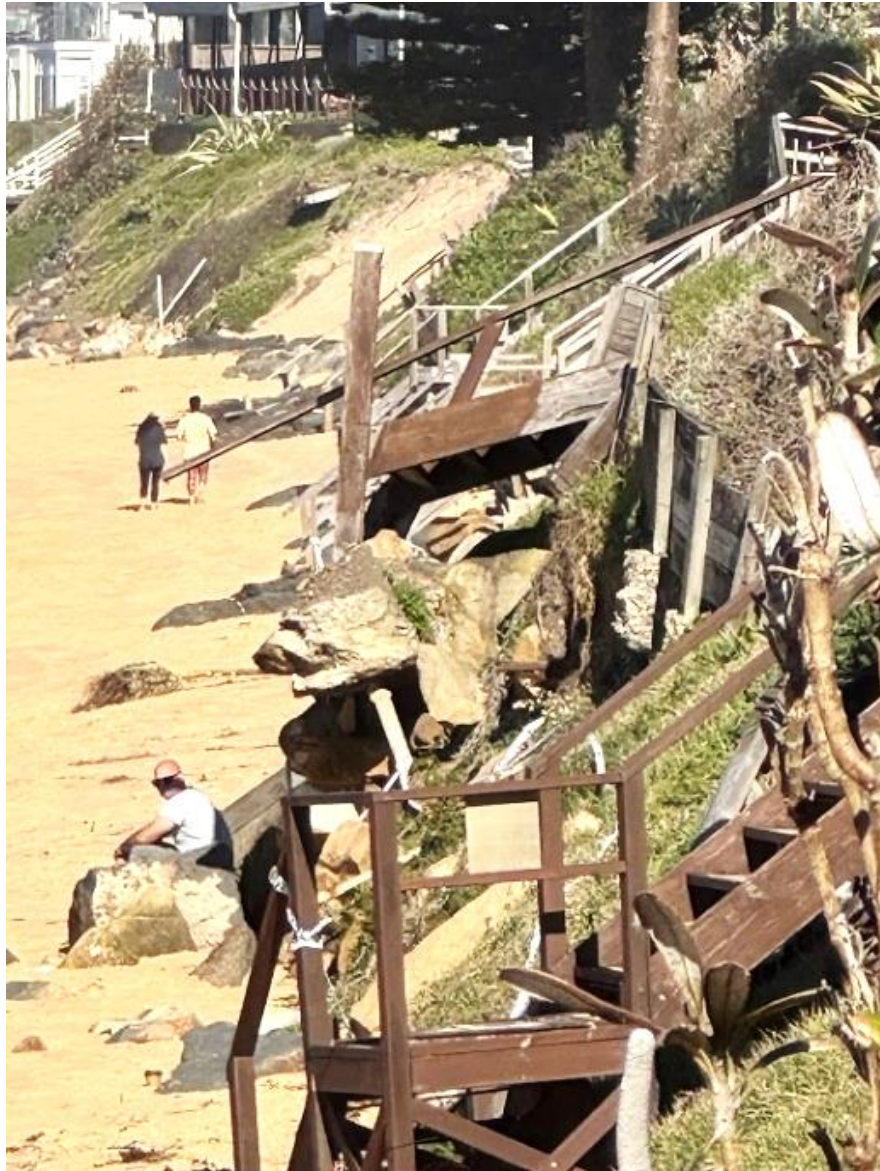
Photo 2.1: Person in a danger zone (see Photo P16 in Appendix 1)-**1/6/2025**

An illustration of a person being in or very close to a danger zone is given in Photo 2.1, below.

Public access to the base of the scarp should be restricted with barriers and signage. The community generally do not appreciate the dangers posed by an unstable slope at the back of a beach. It offers an attractive opportunity for children to dig in the base of the sand cliff, or to play in holes in the exposed rock works. The materials embedded in the slope or above (such as concrete foundations, retaining walls, or boulders that may weigh upward of 100kg) can be dislodged without warning."

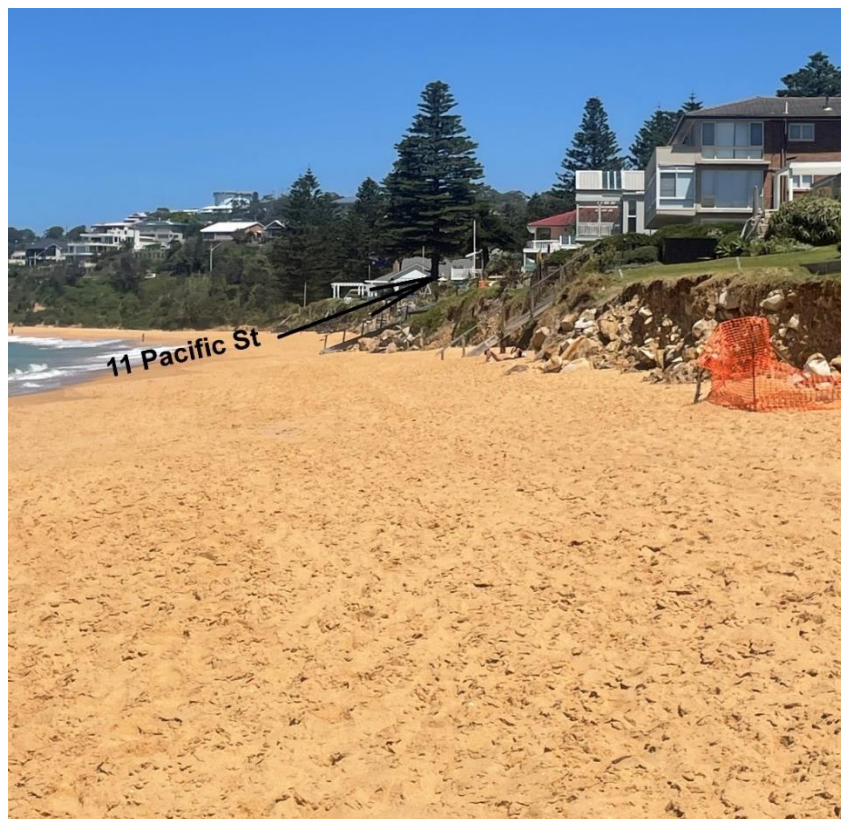
P1: Southern portion of Beach 10 Oct 2025

The beach condition on 10th October comprised an upper sand bench at about RL4m¹¹, about 30m wide in the southern approximately 700m length, and about 50m wide in the northern 500m length (see Photographs P1 and P2, below).

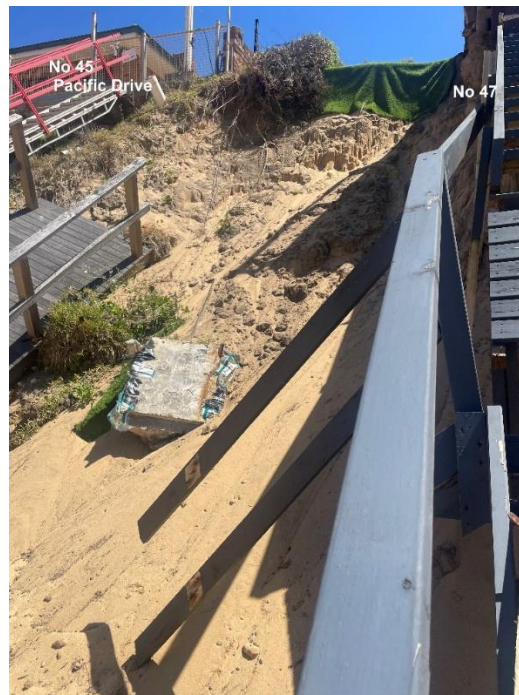
P9: Sand slope between 45 and 47 Ocean View Drive

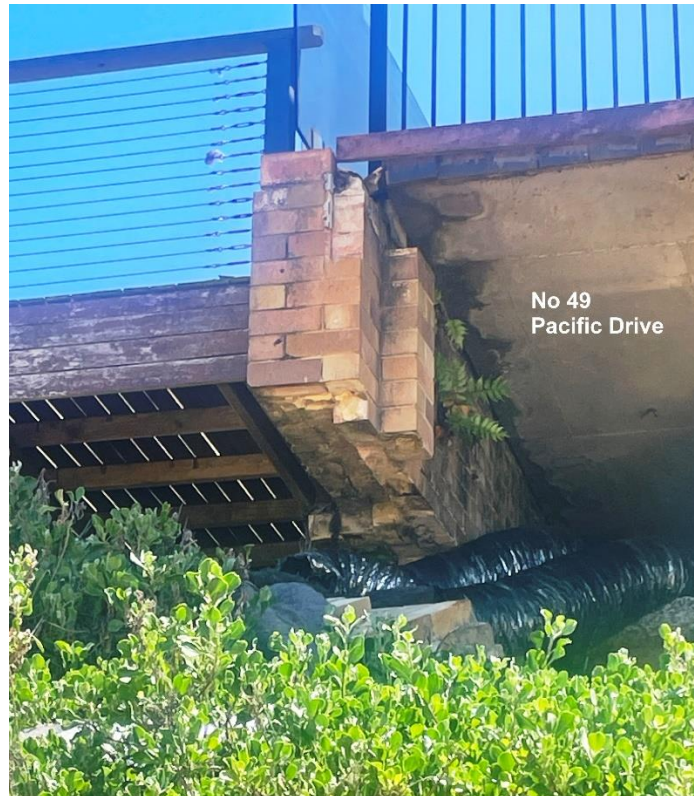
P10: Undermined structural wall at No 49 Ocean View Drive

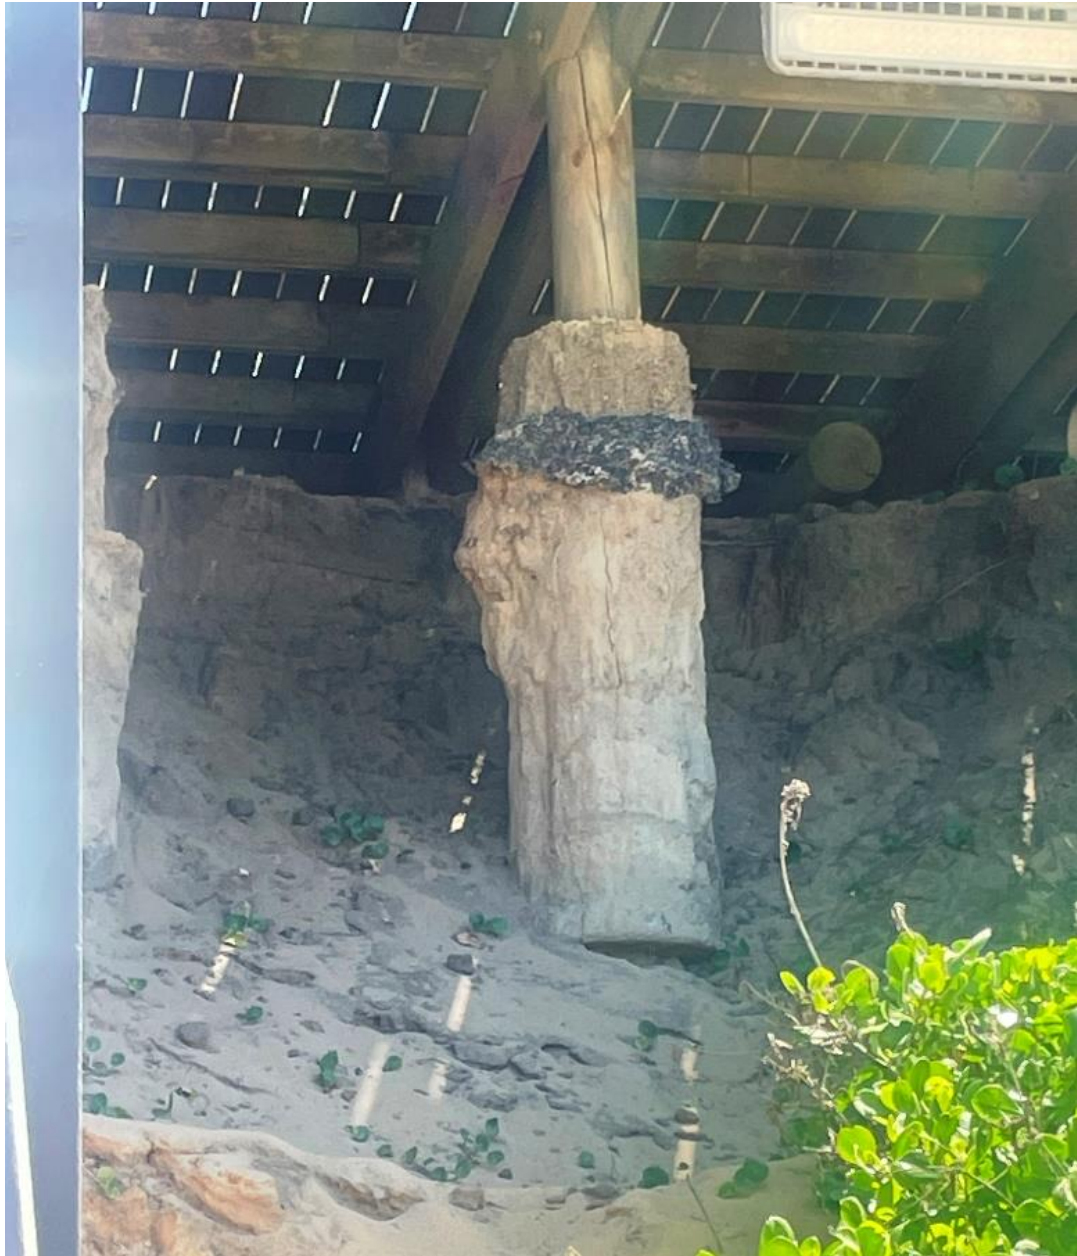
P12: Undermined pier at No 47 Ocean View Drive

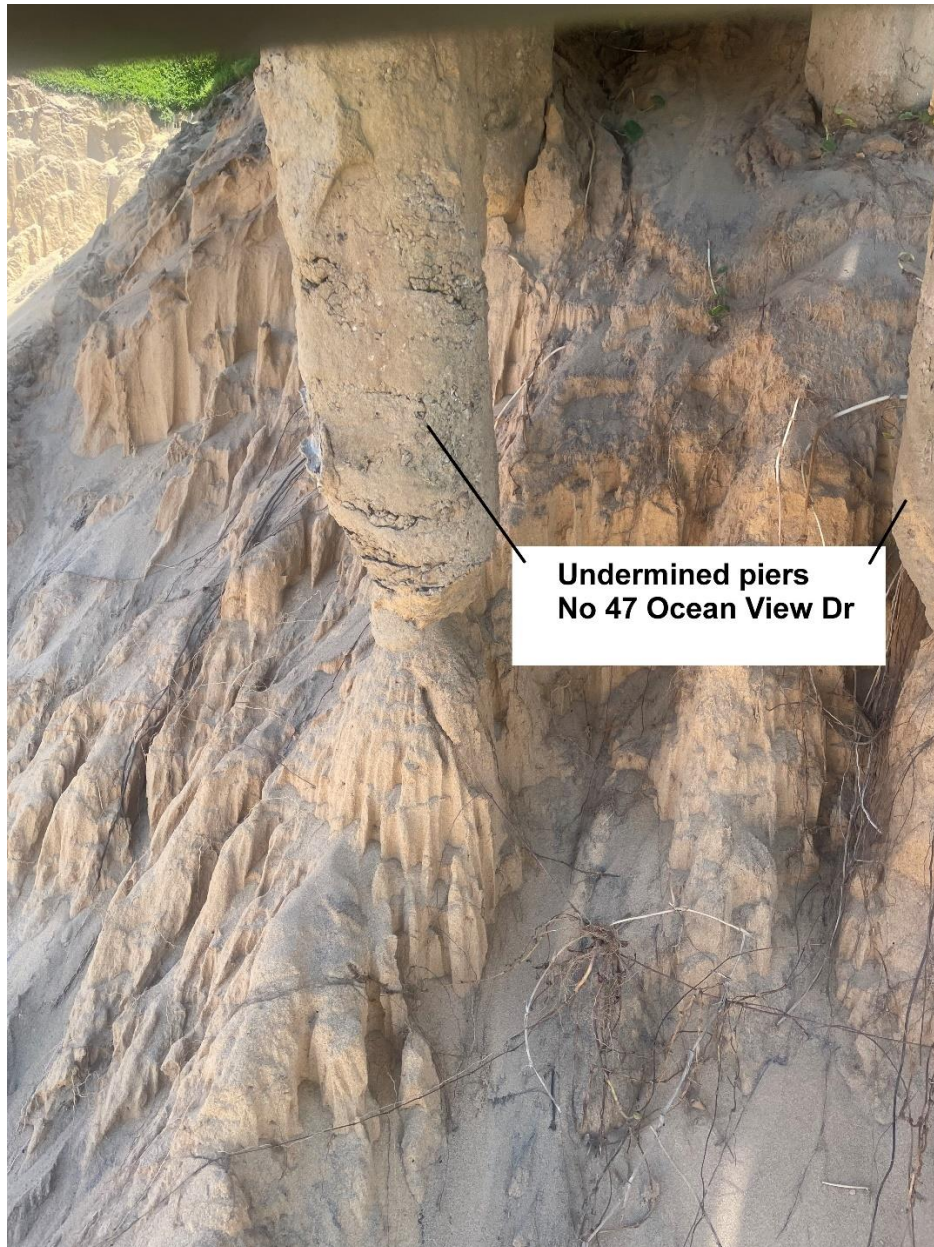
P13: Other undermined piers at No 47

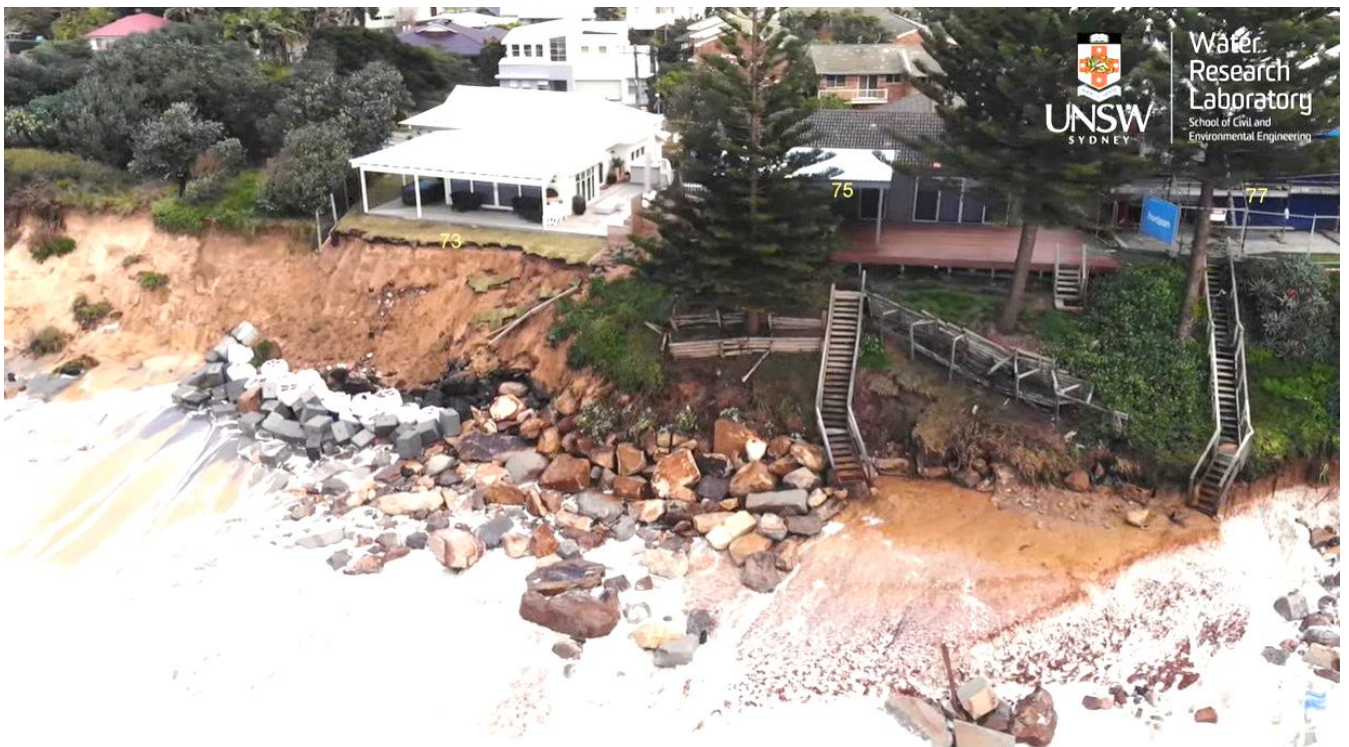
P17: Erosion at No 75; 17 July 2020

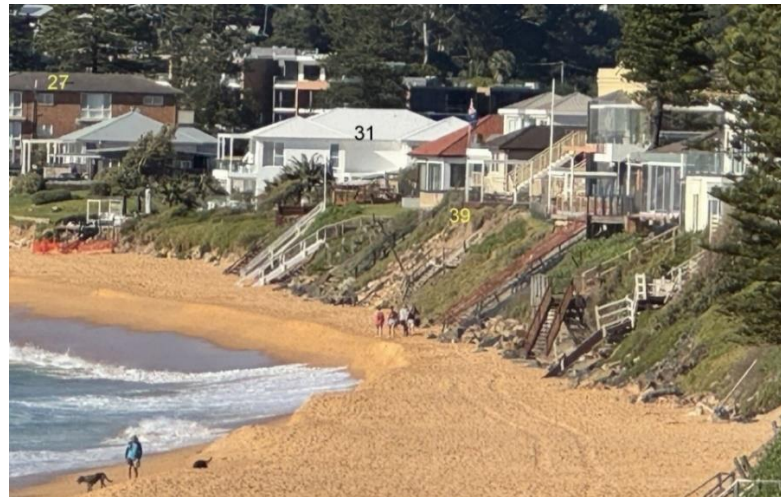
A matter of relevance that illustrates the vagaries of beach erosion is the fact that within a few days of my inspection of 10th October an approximately 1m erosion scarp had developed where I had seen a uniform sloping beach and a 30m to 40m wide, near flat upper part (see Figure P20). By the 23rd of Oct there was a portion of beach where the upper-level part was only about 6m wide; by 24 Oct it was 1.5m wide at this location. This occurred during a benign ocean period where the Sydney Waverider measured as shown below.

P20: Photograph from North showing 1m to 2m high scarp opposite 37 and 39 Ocean View Drive; morning 23 Oct 2025

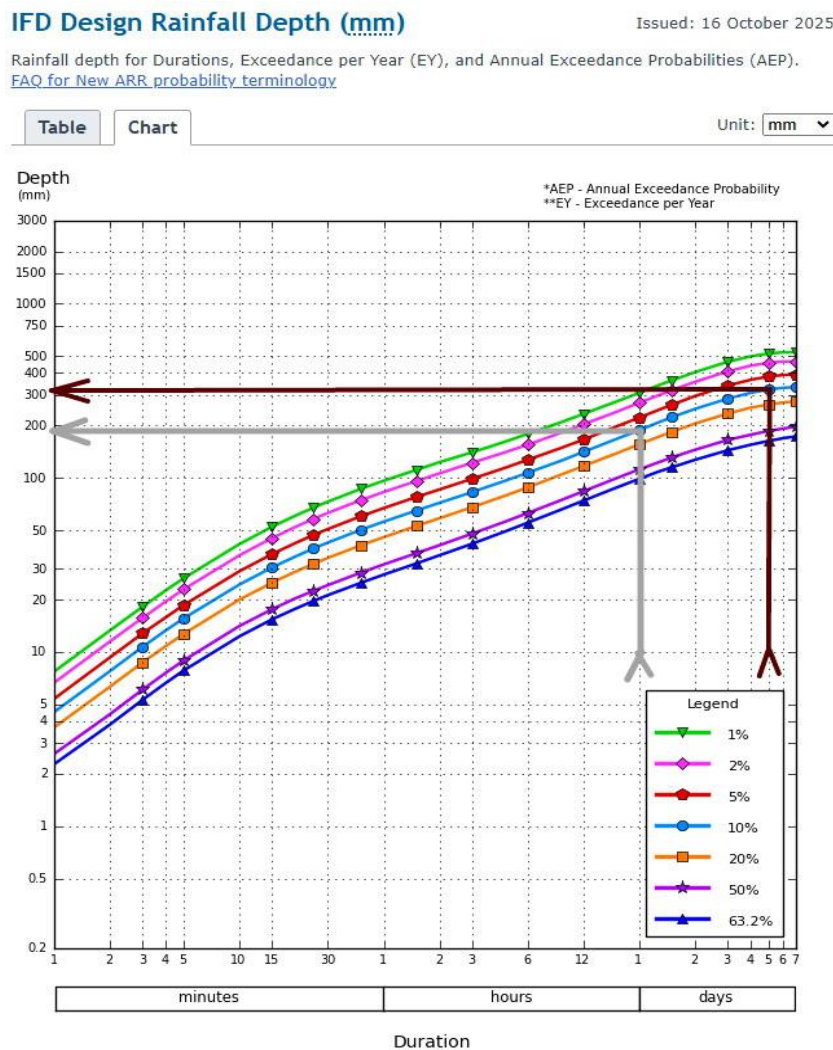
The Bureau of Metrology rainfall intensity-duration-recurrence interval plot for Wamberal is given below. From this I adopt the 1 in 10 yr one day rainfall as 200mm, and the 5-day rainfall as 300mm.

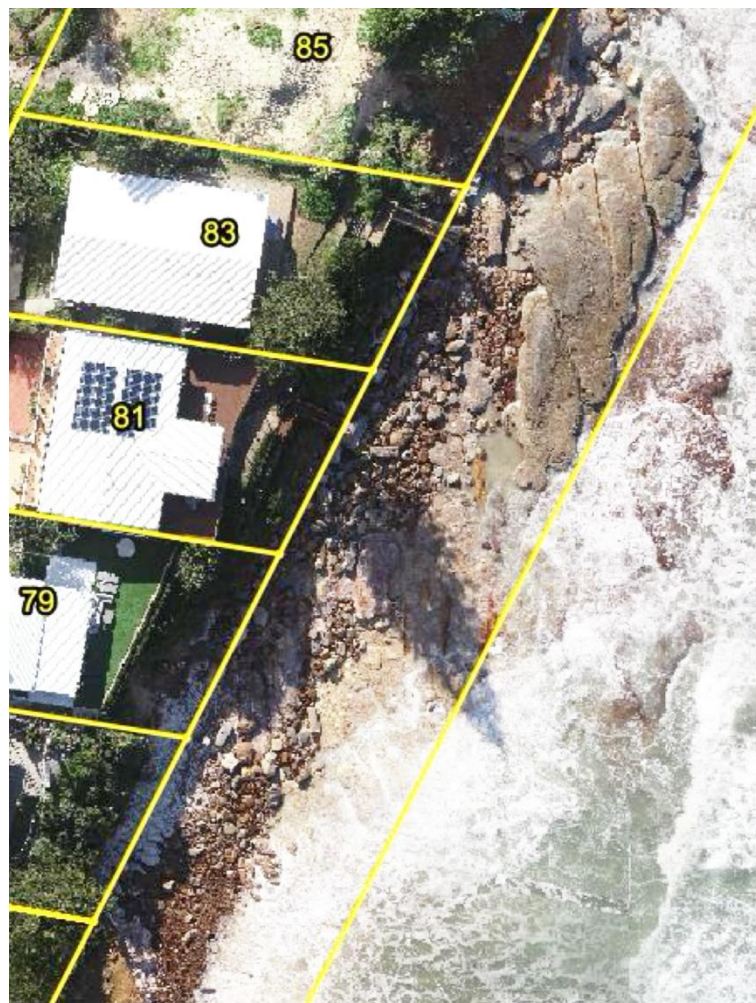
A relevant matter to potential land instability is the fact that for an approximate 400m length of the beach a metre or two of sand normally covers bedrock at between RL -2m and RL 1m. This bedrock is exposed in and after periods of erosion (see Photo P3.1). The importance of this is that this exposed bedrock is the Patonga Claystone Formation. This is a notorious¹³ Formation implicated in land instability in the Central Coast region because of low shear strength when saturated^{14, 15}. It underlies properties such as Nos 73 to 95 Ocean View Drive (see Photo 3.2) and is, in my opinion, most probably a controlling factor in the deep-seated instability at Nos 93 to 97 Ocean View Drive (see Photo 3.3).

P3.1: Patonga Claystone Formation exposed following erosion

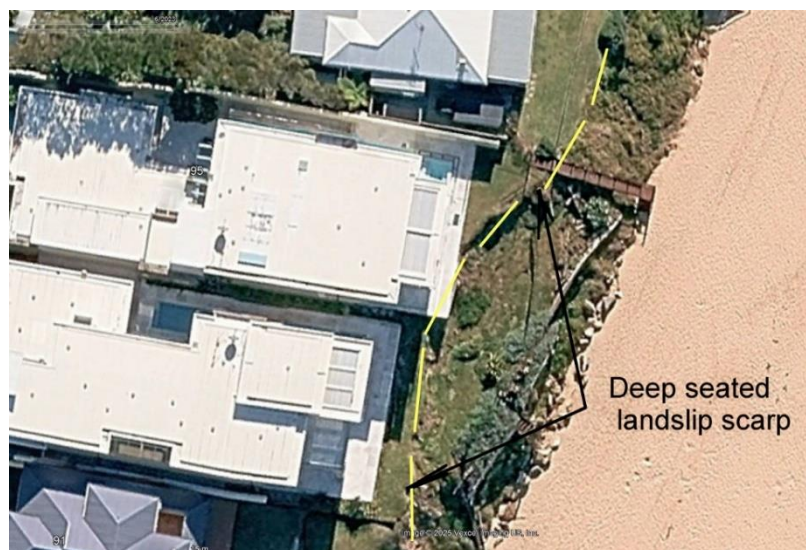
P3.3: Deep seated landslip; 93 to 97 Ocean View Drive

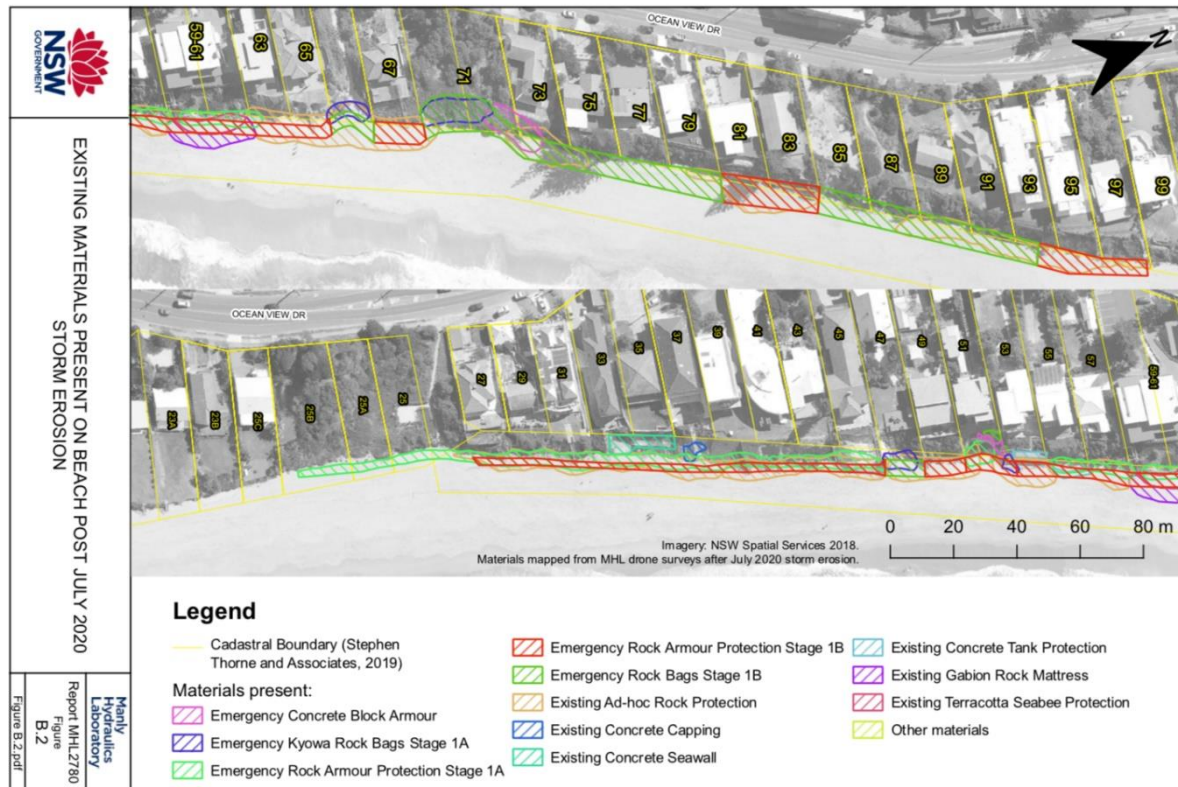
P3.4: MHL drawing of existing works post 2020 but pre-2022

For obvious reasons detailed engineering documentation of the *ad hoc* protection works that have been placed/built since the 1974 storm do not exist. Even the emergency works with rock boulders and rock bags in 2020, 2022 and 2025 were not done to engineering specifications and then surveyed and measured as-constructed. Figure P3.4 is a drawing prepared by the Manly Hydraulics Laboratory

I have found the MHL drawing reproduced in P3.4 difficult to interpret, mainly because the same colour appears to be used for different works. In an attempt to figure out what was where, I enlarged the drawing in pieces and superimposed on the Google Earth aerial photograph, as presented in P3.5 to P3.9.

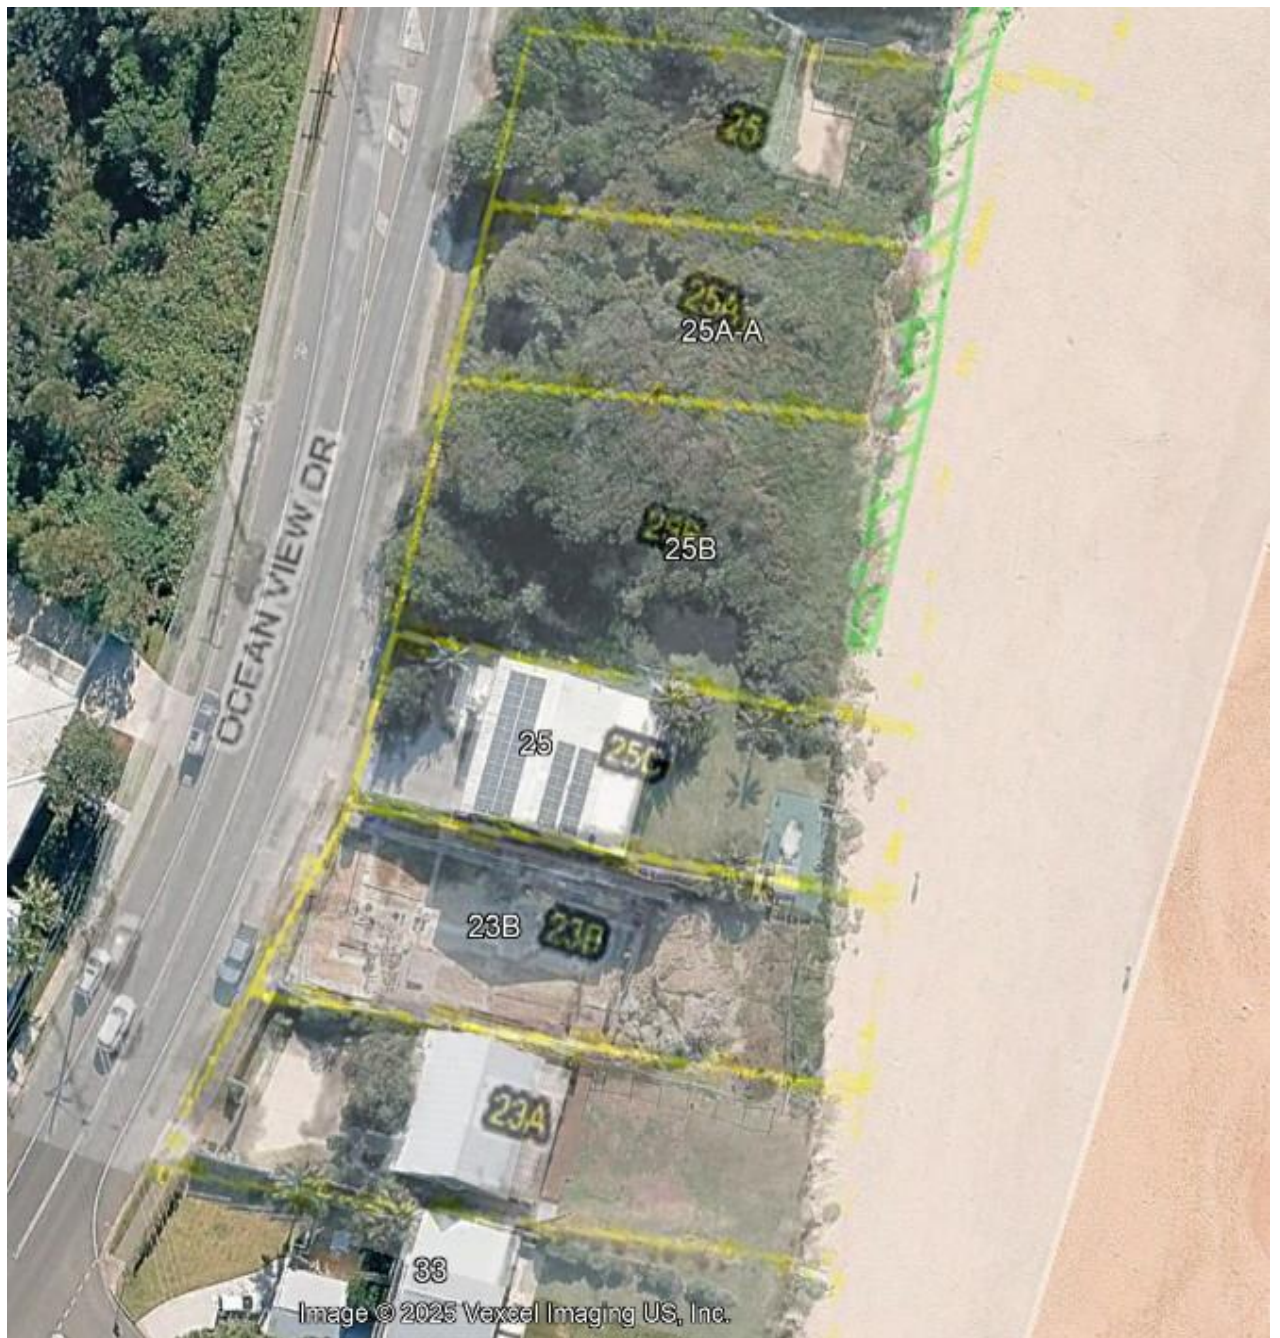
P235 23A to 25 Ocean View Drive

Also shown on these photographs are places where I could see the tops of rock bags, or rock boulder revetment, on 10 and 24 October 2025.

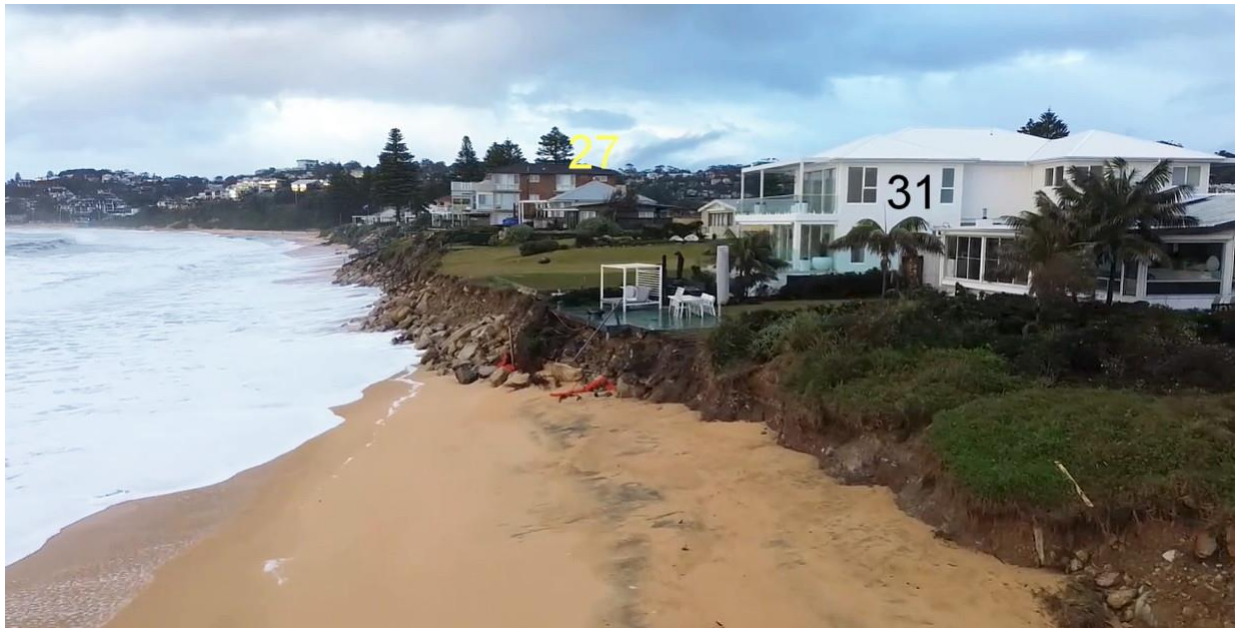
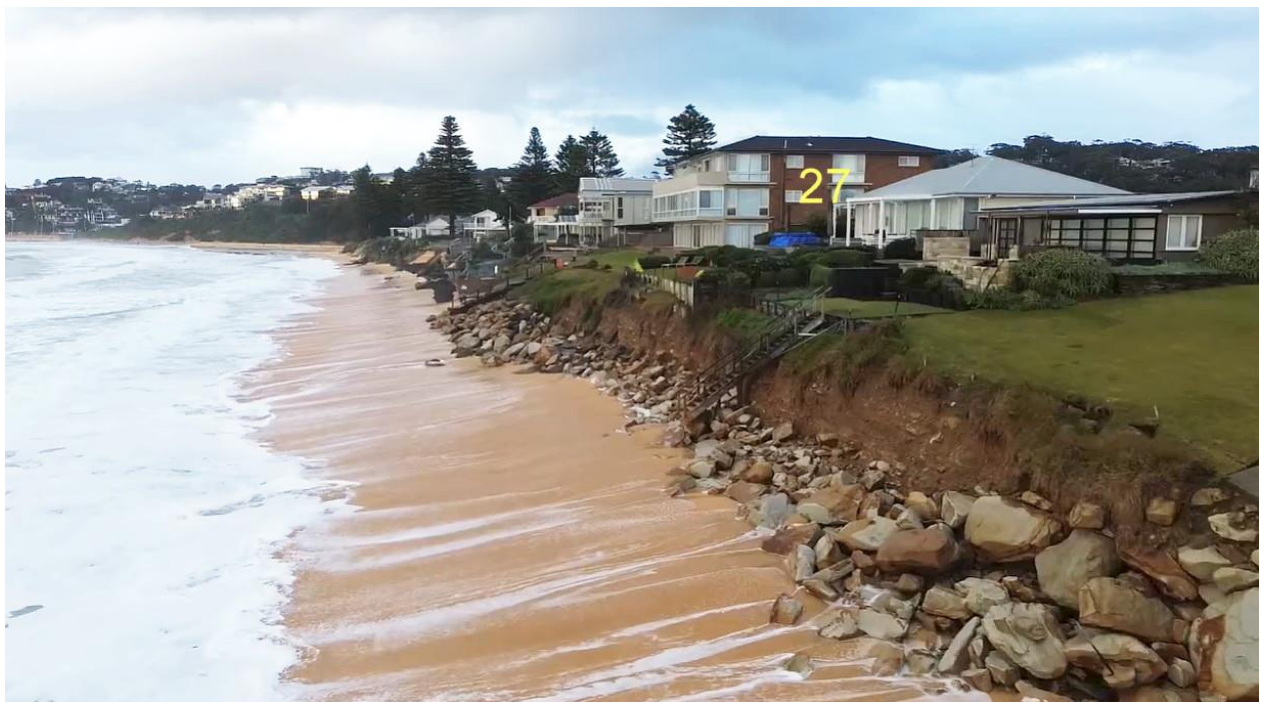
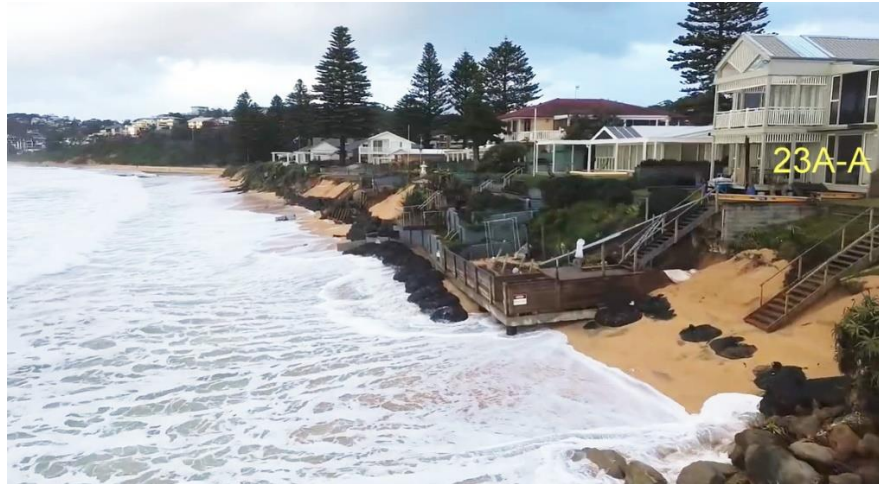
P3.10: Still from drone survey – correct date uncertain (possibly 2025)

In an attempt to resolve my dilemma, I set about examining videos and photographs available on the Internet. For example, P3.10 to P3.11 are stills taken from a Newcastle Herald drone-video¹⁶, which give good views of existing ‘defensive’ works south of about No 31 Ocean View Drive. However, I cannot fix an accurate date for this video.

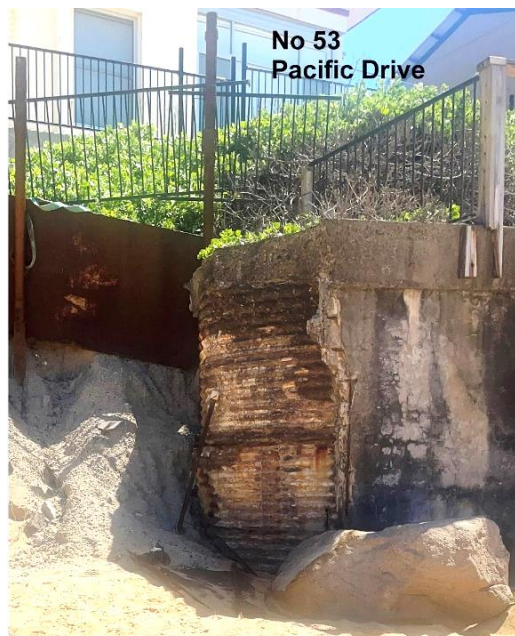
P2.13: Southern end of concrete wall at No 53

Almost all the existing works (an exception being the concrete wall at No53 Ocean View Dr shown in P3.13) are located below about RL4m¹⁷, but with foundations at different levels, most on sand but some on Patonga Claystone Formation

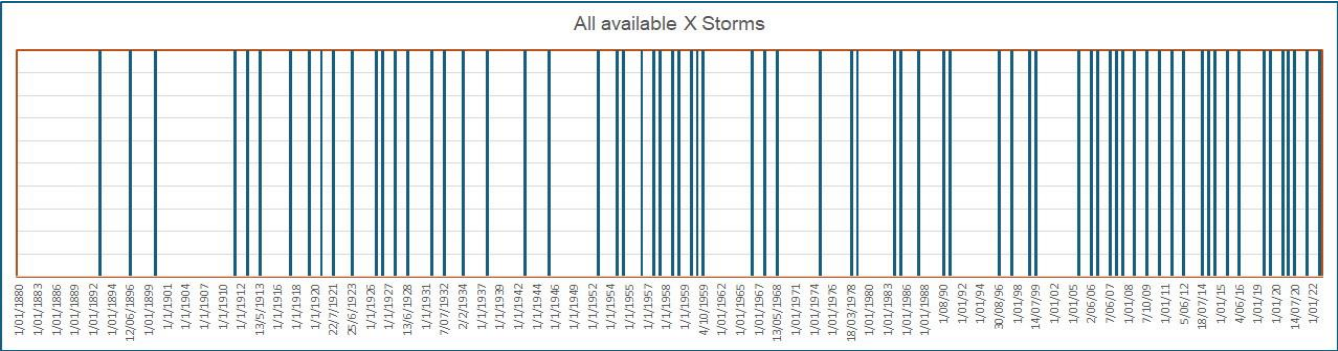
Figure 4.1: X severity storms plotted against date.

On average, for 140 years, **X** severity storms occurred as 1 in 2 years recurrence interval. This is consistent with a statement by the Central Coast Council that “this 2020 coastal erosion event was not rare and has a 50% chance of occurring in any given year.”

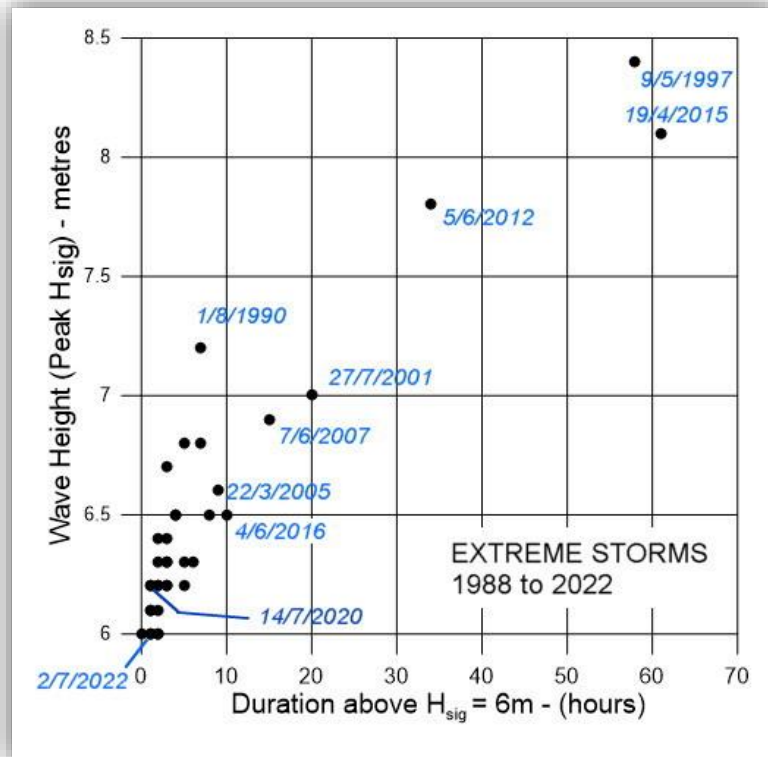
Fig 2: Extreme storms 1988 to 2022

The 1997 storm occurred on 9 to 12 May; the preceding category B storms were in Nov 1996 and Jan 1997.

The 2015 storm was 19 to 22 April, with category B preceding storms in early December 2014 and early March 2015

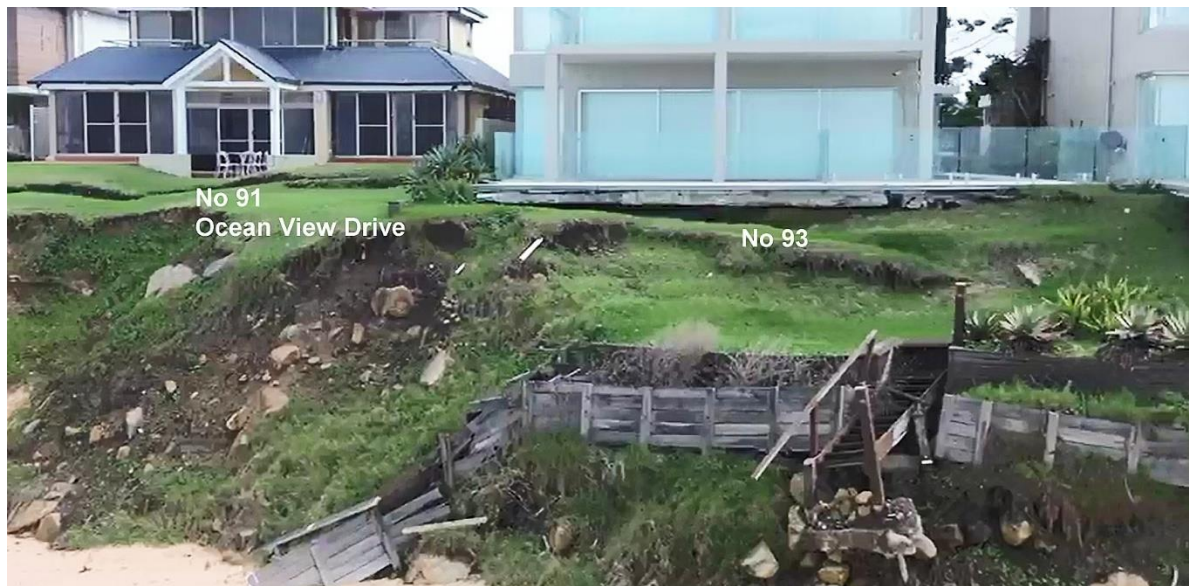
No 91 and No 93 Ocean View Drive – 23 May 2025

“Remobilisation of the earlier failure that affected 91 – 95 Ocean View Drive. Should retriggering of this slide occur, it is likely that this would result in damage to one or more of the residences within these three properties.”
