JOURNAL OF THE CONSTRUCTION DIVISION

REINFORCED ROCKFILL FOR CONSTRUCTION FLOOD CONTROL

By Philip J. N. Pells¹

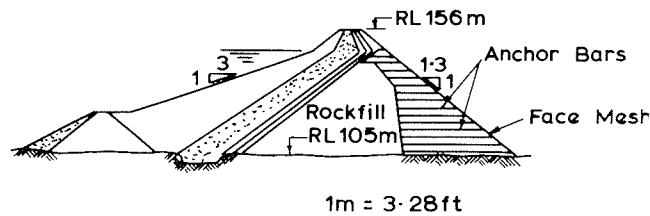
FIG. 1.—Bridal Drift Dam-Cross Section

As shown in Fig. 1, the Bridge Drift dam is a sloping core rockfill structure constructed originally to a height of 167 ft (51 m), and subsequently raised

to 177 ft (54 m). The downstream rockfill zone, constructed ahead of the core and upstream zone, is composed of dolerite from the 180-ft (55-m) deep spillway excavation. At the time when the major flood occurred the downstream rockfill had reached a height of 50 ft (15 m) above river bed level but construction of the core had not yet commenced.

The downstream rockfill zone was placed in 3-ft to 5-ft (1.0-m to 1.5-m) layers, watered and compacted by 10-ton (9,100-kg) vibrating rollers. The rockfill reinforcement was based on the practice current in Australia at the time (3,4), but modified on the basis of model tests. The reinforcement thus consisted of two layers of quite light weldmesh on the downstream face, anchored back with horizontal bars at 10-ft (3-m) vertical intervals. Very heavy anchorage was provided because at the time the big concern was with the possibility of deep seated sliding during overtopping. Thus the lower anchor layers consisted of 1-1/2-in. (38-mm) diameter bars at 9-in. (230-mm) centers. The spacing these anchor bars increased in the higher layers while above a height of about 100 ft (30 m) the anchor layers consisted of 3/4 in. (19-mm) bars at 5-ft (1.5-m) centers. The surface weldmesh was made up of 0.28-in. (7-mm) diam wires horizontally at 6-in. (150-mm) centers and 0.2-in. (5-mm) diam wires down the face at 9-in. (225-mm) centers.

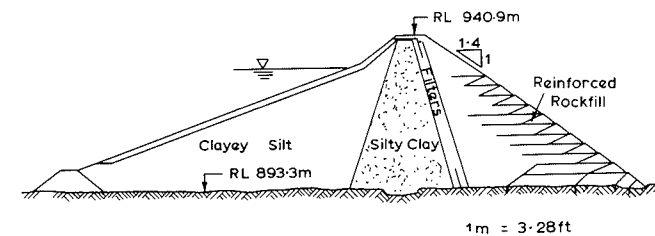
FIG. 3.—Cross Section of Xonxa Embankment

The Xonxa dam is a 158-ft (48-m) high composite earth and rockfill structure with a typical cross section as shown in Fig. 3. The dam is on the White Kei River in the Eastern Cape region of South Africa. The river has a small

The site is at a point where the river flows through a very short gorge associated with a major dolerite intrusion. The river floor and lower portions of the right flank consist of massive fresh dolerite at the surface. However, the left flank can best be described as consisting of a classic dolerite residual profile as shown in Fig. 4. The problem was the difficulty in defining, from the limited borehole data available, at what depth one was out of residual "boulder" formation and into sound dolerite. This problem was to play a large part in the subsequent failure.

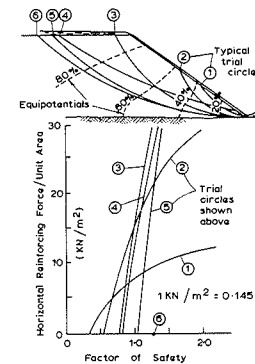
FIG. 5.—Determination of Anchorage Force for Stability Against Deep Seated Sliding

The danger of deep seated sliding arises from the development of seepage pressures within the rockfill during the passage of a construction flood. It was realized during the design of Xonxa that with the strong layering that occurs in compacted quarry run rockfill it was possible that no significant seepage pressures would develop within the relatively short duration of a construction flood. If this were so then deep seated sliding would not be a possibility and the only reinforcement required would be a strong mesh on the downstream face tied back a short distance into the embankment. This aspect is covered further at the end of this paper but at Xonxa, as no quantitative information was available to determine the time required for seepage pressures to develop, long anchorage bars were provided assuming the development of full internal seepage pressures.

1. For a given embankment height the approximate flow net for the most critical flow condition (full overflow with zero tailwater depth) was determined taking into account the layering of the rockfill.
2. The unreinforced slope was analyzed using Bishop's simplified slip circle method to determine the shallowest circle, which without reinforcement had the desired factor of safety of 1.2. This determined the limit of the anchor bars, as deeper circles had a higher factor of safety.
3. The modified Bishop equation was then used to calculate the anchor force required to raise the factor of safety of shallow slip circles to the value of 1.2.

The preceding method is shown in Fig. 5. It was recognized at the time
