Copeton Dam: Performance of the Great Scour Case Study in the floods of 2022

Steven Pells¹, Alex Duwell², Hetal Parmar³.

Erosion of the spillway at Copeton Dam in the 1970's captured worldwide attention. Much was published about the unexpected erosion, although studies considered only geological factors. Some remedial works were implemented, but erosion remained a critical concern. This paper provides an overview of historical scour issues including recent studies which considered hydraulic analysis and scour modelling.

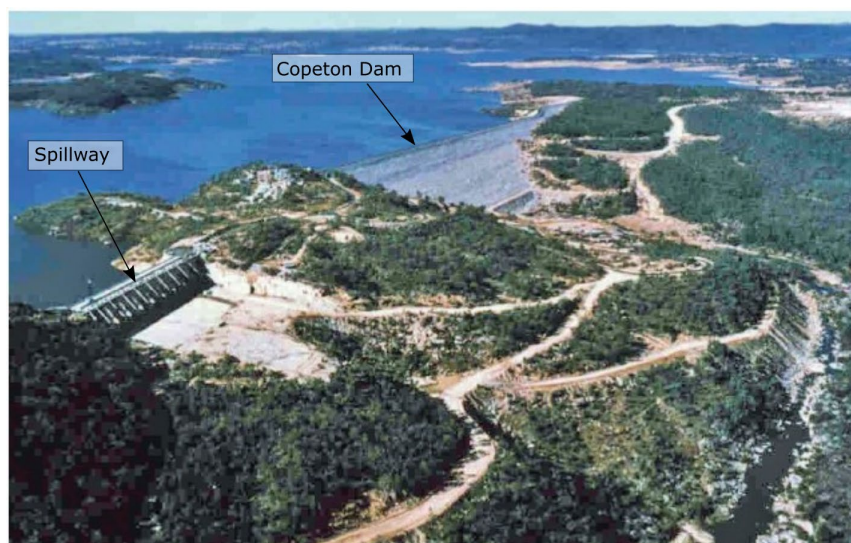
Construction of Copeton Dam was completed in 1973 and included a spillway excavated through a ridge 600 m west of the main embankment. The 158m wide spillway channel released flows onto a steep natural hillside to return to the Gwydir River (Figure 1). A control structure for the spillway includes 9 by 14.63m wide bays into which radial gates were installed in 1976. The spillway experienced its first flows in 1976 during first filling (Figure 2) which resulted in extensive erosion of the granitic rock mass, including carving a defined slot at the location of the existing natural gully. In response to this unexpected erosion, a dividing wall was added in 1977 to demarcate a Service Spillway (Gates 6 to 9) and a Secondary Spillway (Gates 1 to 5) (Figure 3), the rationale being to operate the Service Spillway preferentially as the rock mass in this region was considered to offer better resistance to erosion. Concrete repairs were also done, including concrete works just below the apron of the Service Spillway (known colloquially as 'the swimming pool').

Figure 1 – Overview of Copeton Dam and Spillway after construction, c.1973

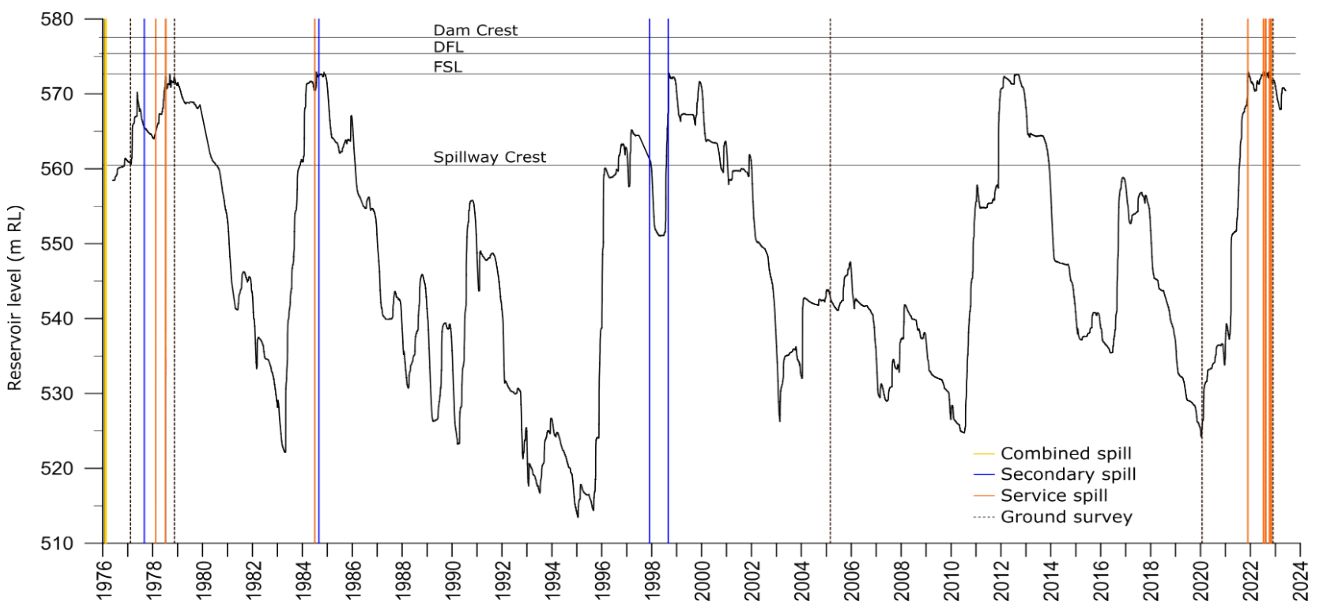
The spillway at Copeton Dam has historically not spilled often. Reservoir levels since 1976 are presented in Figure 4 with annotations showing flow events and when topographic surveys were undertaken.

Figure 4 – Timeseries of reservoir levels at Copeton Dam showing times of spills and ground surveys

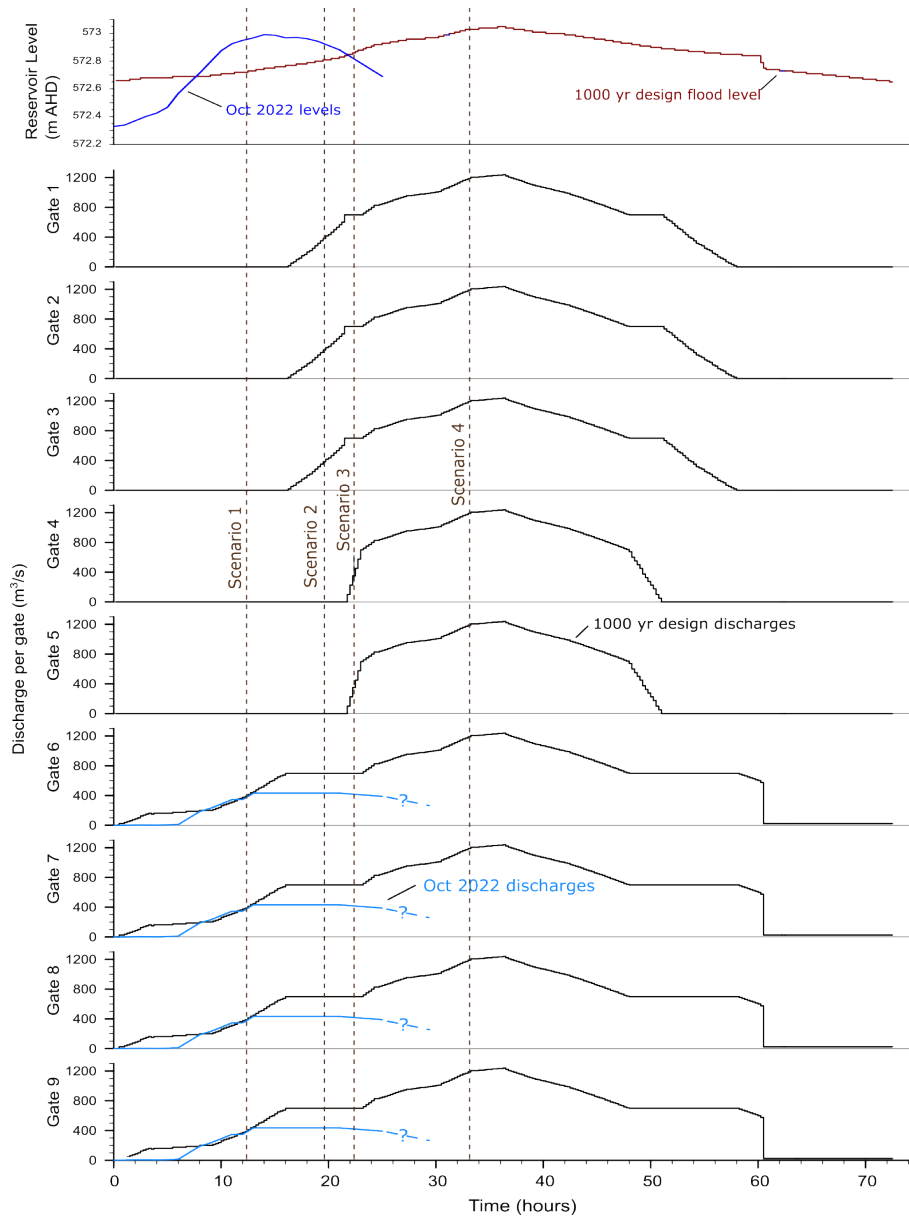
Figure 7 – 1000 AEP Design Event showing Scenarios 1 to 4 used to predict scour (2021), and October 2022 flows

Scour risks assessments made in PSM 2021 chose a discharge condition for Scenario 1 that happens to be representative of the October 2022 event – see Figure 7. This provided the opportunity to review the accuracy of the past assessment, conceding that observed erosion arises from a suite of events between November 2021 to November 2022 and not just from the October 2022 event. The 2021 analysis defined a series of ‘scour domains’, which are the polygons shown in Figure 12. A scour domain is a region that is interpreted to have common geological qualities and common hydraulic loading characteristics. For each scour domain, an ‘erosion vulnerability class’ was determined, based on geological and hydraulic analyses and application of the Pells 2016 method. Each of these classes are associated with erosion quantities, as presented in Table 1. For comparison, the measured erosion quantities from analysis of Figure 12 are also presented. The results are also presented graphically in Figure 13.

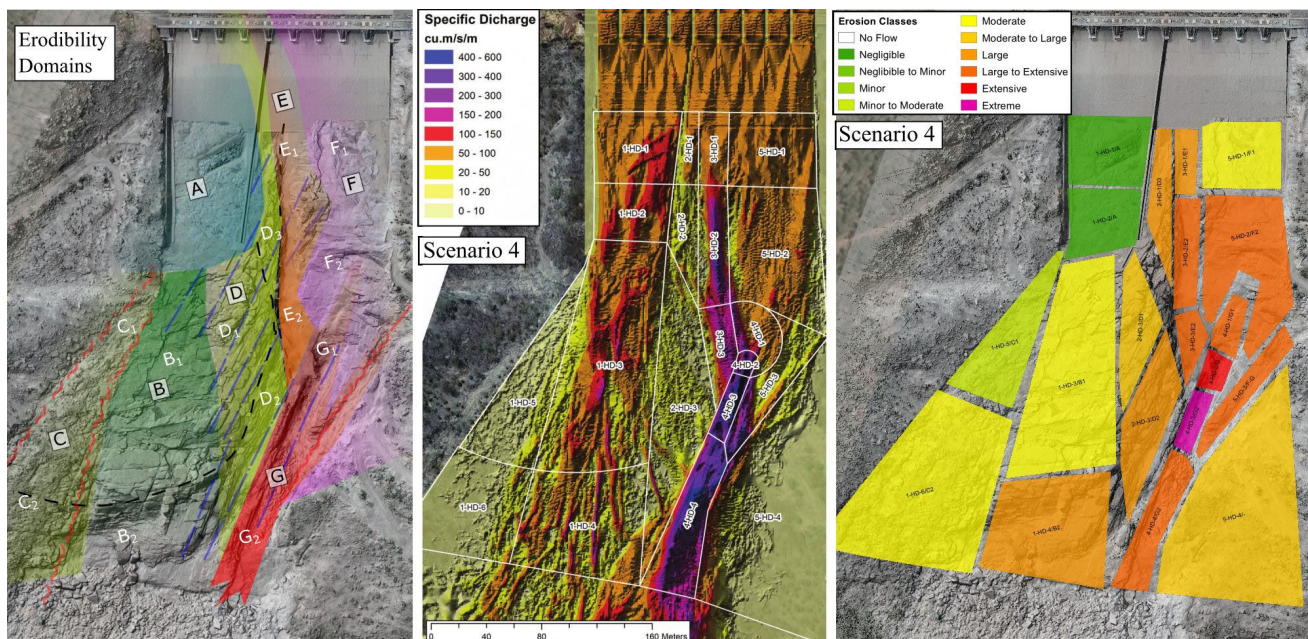
Figure 8 – Examples of scour predictions made in 2021 using the Pells (2016) method

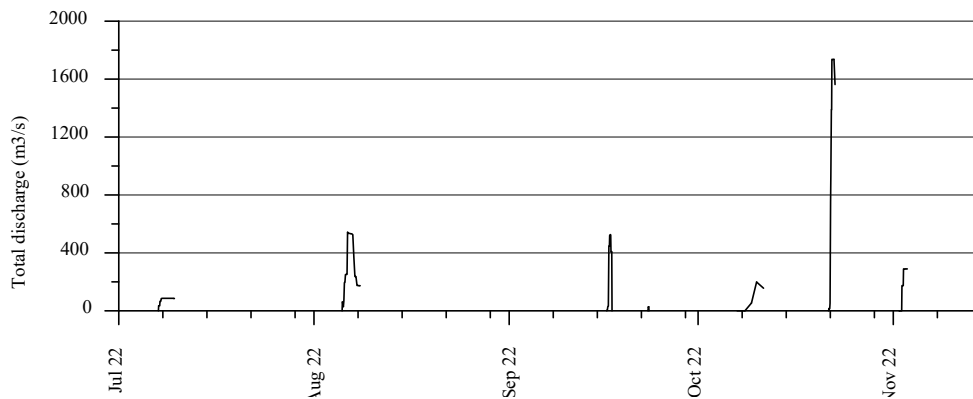
Selected operational records from 2022 were digitised to prepare the timeseries of the flow releases shown in Figure 9. In addition to a small spill in November 2011 (not shown), the records indicate 6 separate flood releases in July, August, September, October (two events) and November 2022. In total, there is approximately 300 hours of flow, with the latter event in 21/22 October peaking at approximately 1700 m³/s (documented in operational records as 150 GL / day), which at the time of writing is the flood of record. The peak flow was maintained for approximately 8 hours and represents around 30% of the Service Spillway design capacity (or 14% of the entire spillway capacity). The October 2022 flood hydrograph is shown superimposed on the 1000 AEP Copeton Dam spillway design flow hydrograph in Figure 7. Note that in 2022 only the Service Spillway was operated.

Figure 9 – Flow records from 2022 events, Service Spillway at Copeton Dam

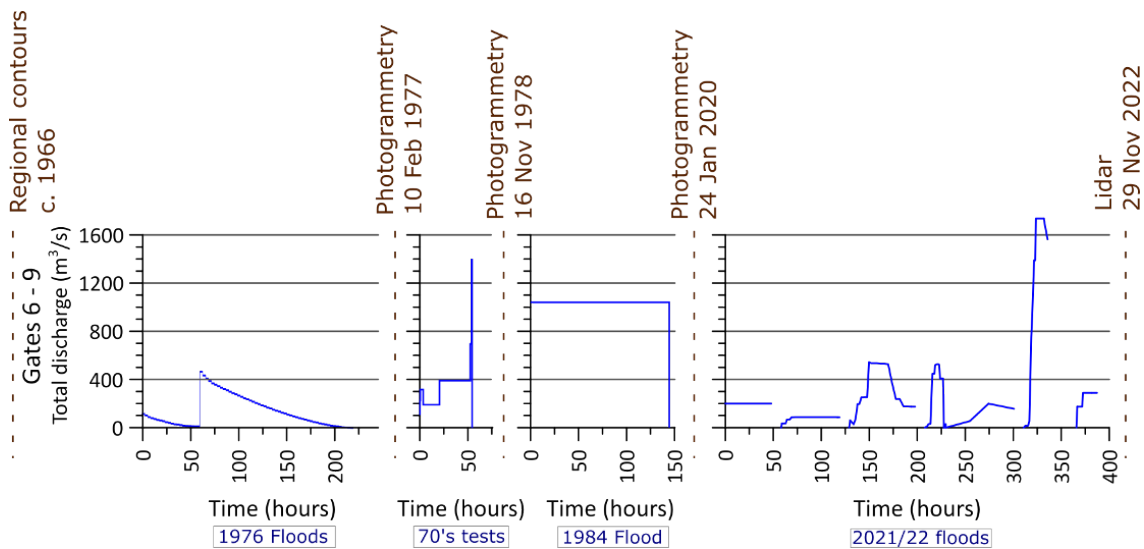
Flows that have passed through the Service Spillway were concatenated into periods of time between sequential ground surveys, as shown in Figure 16. In each case, the rate of headcutting between two sequential ground surveys was estimated as the observed headcut depth divided by the duration of concatenated flows between the sequential ground surveys. A note was also made to interpret if the geology was highly weathered (being representative of first flows over vegetated spillway) or moderate to fresh (for areas previously eroded).

Figure 16 – Flow records in Copeton Dam Service Spillway since construction, concatenated between sequential ground surveys

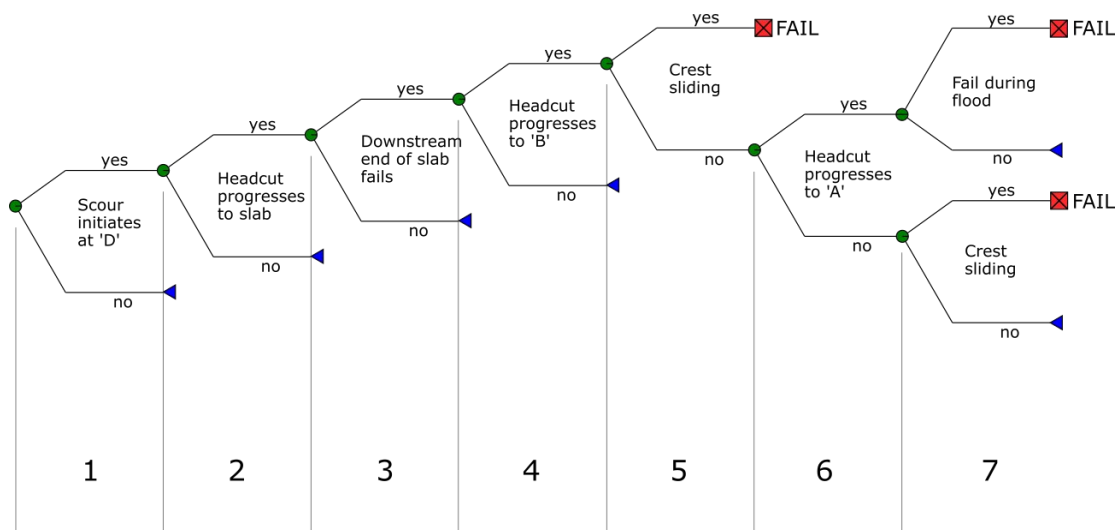
Figure 18 – Event tree layout for scour risks

1. Traditional risk assessment using expert elicitation and engineering inputs resulted in an event tree layout as shown in Figure 18. This individual failure mode was integrated into the overall risk profile for the facility, which noted an elevated societal risk profile. This elevated risk position required controls to be assessed.
2. Understanding of uncertainty, which was found to be approximately 1-order of magnitude due to difficulty of the engineering inputs to assess head cut scouring to undermine concrete slabs without physical hydraulic modelling information.
3. Operational style risk assessment using WaterNSW's corporate consequence matrix to investigate the risk exposure of financial and reputational risks.
4. Risk Management Planning to identify interim or structural risk controls.

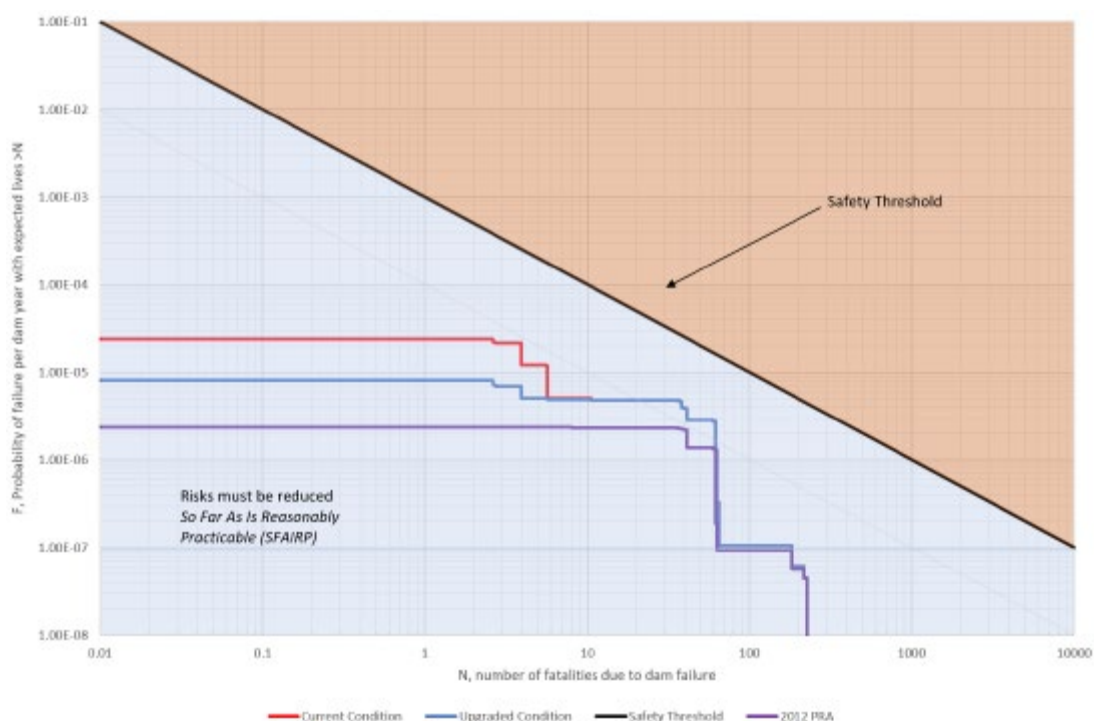
1. Dam breach, life safety risks were below the safety threshold yet not yet deemed SFAIRP without further works to justify. It was observed that significant uncertainty remains as potential 1-order of Magnitude.
2. Non-Breach, reputational and financial risks were far more likely to occur and resulted in 'low' to 'medium' risks. With the rock scouring progressing yet stopping at the concrete lining being considered the highest risk and most likely outcome.

Figure 19 – Risk profile for Copeton Dam with spillway scouring risk included
