HYDRO-GEOTECHNICAL ROCK SCOUR ASSESSMENT AT PETIT-SAUT DAM

Summary. This paper presents a recommended design procedure for assessment of rock scour which is illustrated for the case study of Petit-Saut Dam in French Guiana. The methodology, referred to as a "hydro-geotechnical scour assessment", promotes a multi-discipline approach, applying expertise in both rock mechanics and hydraulics, and guides the diagnosis of scour and response to risk by application of currently available scour assessment techniques.

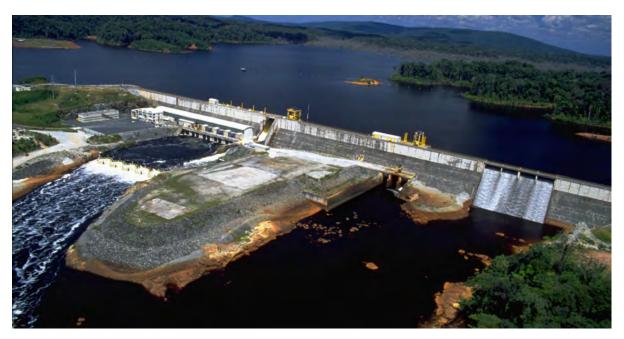
Figure 2: Overview of Petit-Saut Dam (1 July 1995)

The primary dam at Petit-Saut is a roller compacted concrete gravity structure, 740 m long and with crest elevation of 37m NGG and a maximum height 44 m. A photographic overview of the dam is shown in Figure 2. The dam features four (4) outflow locations (Figure 3):

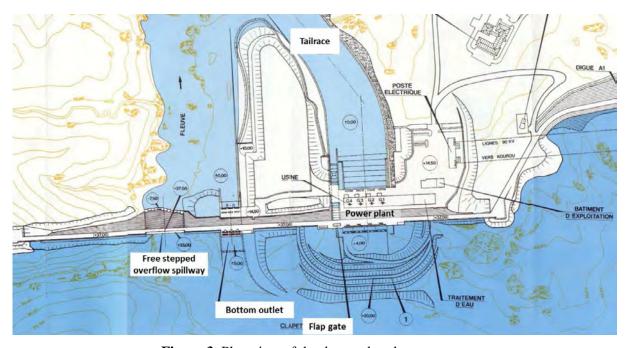
Figure 3: Plan view of the dam and outlet structures

- 1. Four power plant turbines discharging to the tailrace via a re-oxygenation weir
- 2. The bottom outlet which features three gated outlets
- 3. A 60m wide free overflow stepped spillway, located on the left bank.
- 4. A single 10m wide outlet gate adjacent to the powerplant.

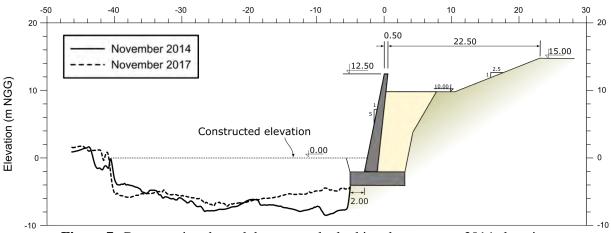
Figure 7: Cross-section through bottom outlet looking downstream, 2014 elevation

- A large scour hole has developed, which has a shape that clearly reveals that rock mass has been removed between persistent subvertical and upstream-dipping joint sets, which strike perpendicular to the flow direction. The upstream dipping defect-surface is interpreted to be sheet-jointing. The remaining rock mass has the appearance of fresh granite, and it is postulated that the scour hole shape reflects the extents of a deeper but localised weathering zone, as is commonly observed in granitic formations.

- Erosion against the retaining wall has revealed the wall footing, reflecting preferential operation of Gate 1 prior to 2014 but may also have been facilitated by rock-mass disturbance from excavation for the wall footing.

- The erosion profile in Figure 6 follows the decline of the wall footing, which may indicate the profile of competent rock, as sought and encountered during construction of the wall.

Ongoing monitoring of the rock mass downstream of the bottom outlet was recommended. This would comprise repeated bathymetric surveys after two or three significant flow events. Surveys should endeavor to assess the extent of undermining of the wall footing.

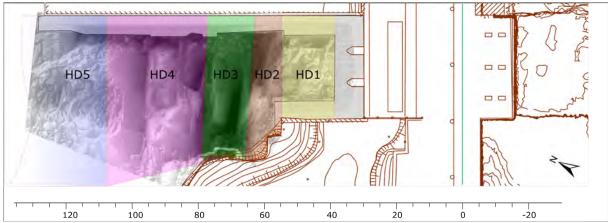
Figure 11: Interpreted hydraulic domains

Five different hydraulic domains (HD) were defined as shown in Figure 11. Assessed hydraulic indices for each HD is presented in Table 2. The following observations are made on the results from FLOW3D:

- Releases from the Gate 1 with the as-constructed topography show the high-velocity jet remaining close to the wall and extending over the excavated section without entering a hydraulic jump. This, along with the possibility of disturbed rock mass adjacent to the retaining wall toe due to excavation for its footings, may explain the elongated extent of erosion observed adjacent to the retaining wall.

- With development of a scour hole, the extent of high velocity flows and high energy dissipation is shortened, and focused onto the upstream region.
- The locations of peak hydraulic dissipation are similar for flows from the left hand and right hand gates. The peak hydraulic dissipation extends from the end of the concrete lining and over the upstream edge of the bed-slope descending into the scour hole.

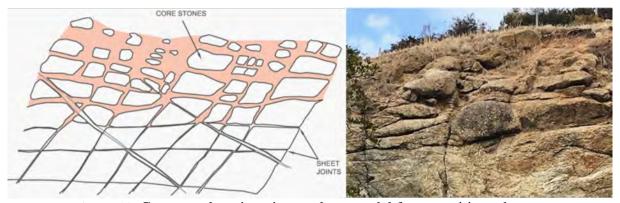
Figure 12: Conceptual engineering geology model for a granitic rock mass

A conceptual engineering geology model for a granitic rock mass, based on experience in similar conditions, is summarised in Figure 12. The primary features are:

- Corestones, rounded boulders of largely unweathered rock in a matrix of weathered soils. They occur individually or in piles as a result of chemical weathering.
- Sheet joints, which are highly continuous defects that form as a result of stress release. These joints are more closely spaced near the surface and can extend to depths of greater 60m. These joints are commonly referred to as "onion skin weathering".
- Irregular weathering profile, which is related to preferential weathering along joints (particularly sheet joints) and the development of corestones.

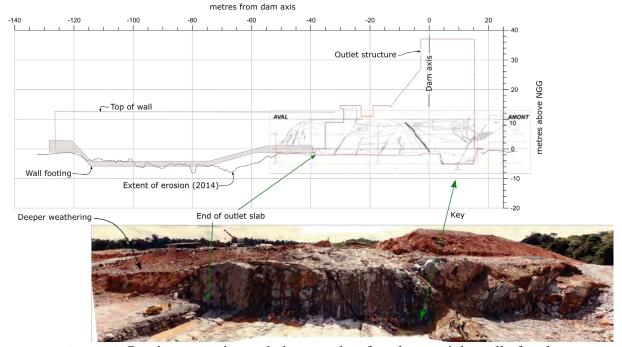
Figure 13: Previous mapping and photographs of geology – right wall of outlet

Geological data were compiled from various sources, including regional geological maps in the public domain and geological reports, site investigations, laboratory measurements, defect measurements, mapping and photographs taken during construction (eg Figure 13). Based on these data sources, four key engineering geological units were defined: soils (sandy-clay laterites); Highly to Moderately Weathered Granite ("HWG"), Weathered Granite

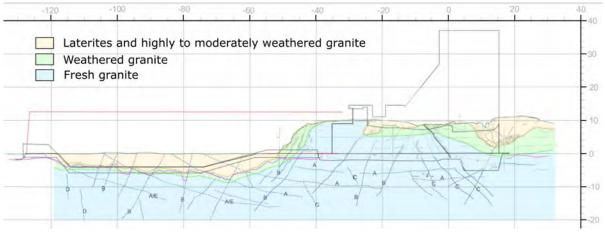
Figure 14: Example of interpreted stratigraphy

("WG") and Fresh Jointed Granite ("FG"). The interpreted stratigraphy in the spillway, comprising these geological units, is presented in Figure 14.

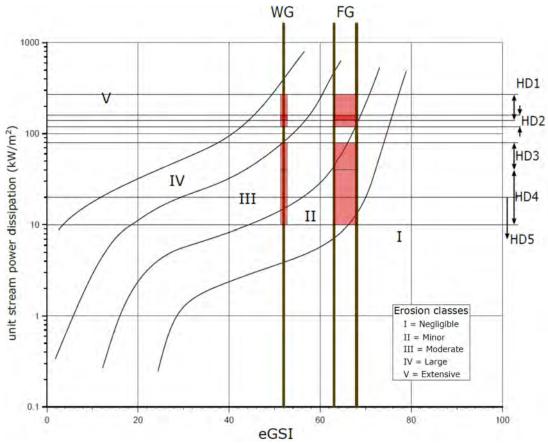
Figure 15: Previous mapping and photographs of geology – right wall of outlet

Various methods have been published which allow an estimation of scour vulnerability of a rock mass based on comparison to case studies, where a rock-mass index is used to compare rock conditions and the unit stream power dissipation is used to compare hydraulic conditions (van Schalkwyk et al 1994; Annandale 1995; Kirsten et al 2000; Pells et al 2016; Douglas et al 2018). These methods were applied to assess erosion vulnerability for each of the scour domains. An example using the eGSI (Pells et al 2016) is presented in Figure 15. Results from the various comparative methods showed general agreement indicating that previously present HWG and WG domains would be subject to moderate to large erosion, but the remaining Fresh granite (FG) domains may experience minor to moderate erosion under future major spills.
